## Inspection of the gearbox components

By Volodjushka

Конференция "Обменяемся опытом. Нива"  
NIVA-FAQ  
undefined

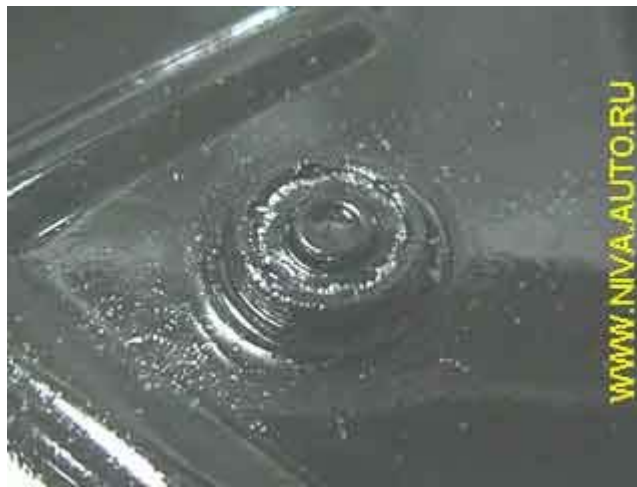
Wash away **the bottom cover and its magnetic plug** from all brass dust of synchronizers and metal fragments:

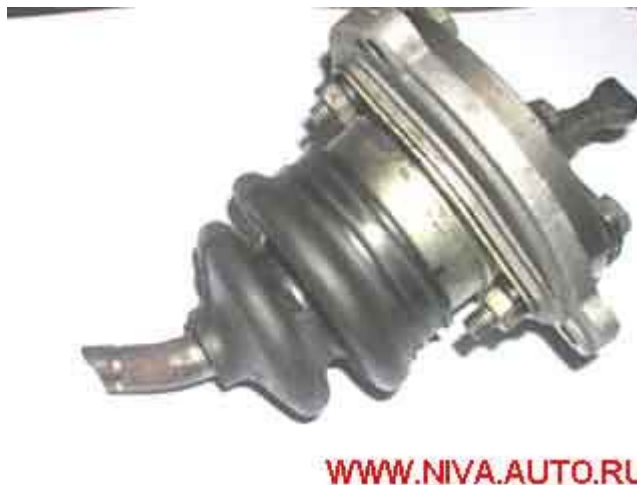
Wash out and examine **the shifting mechanism** for presence of cracks in the lever extension. The mechanism gets out of operation very seldom, but the extension sometimes breaks:

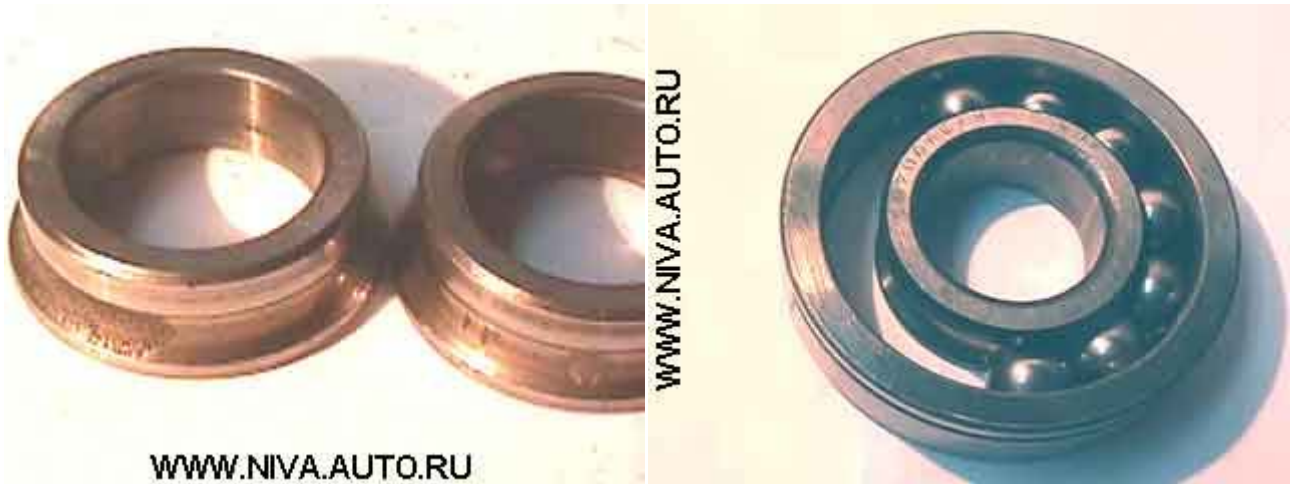
The **bearings** must be washed thoroughly. In the case of ball bearings examine the internal and external races and the ball cages as well:

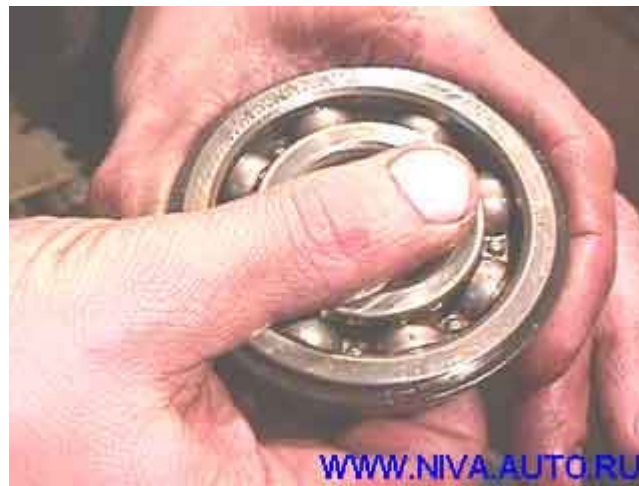
Check the radial play by shaking the races in opposite directions, respective to each other:

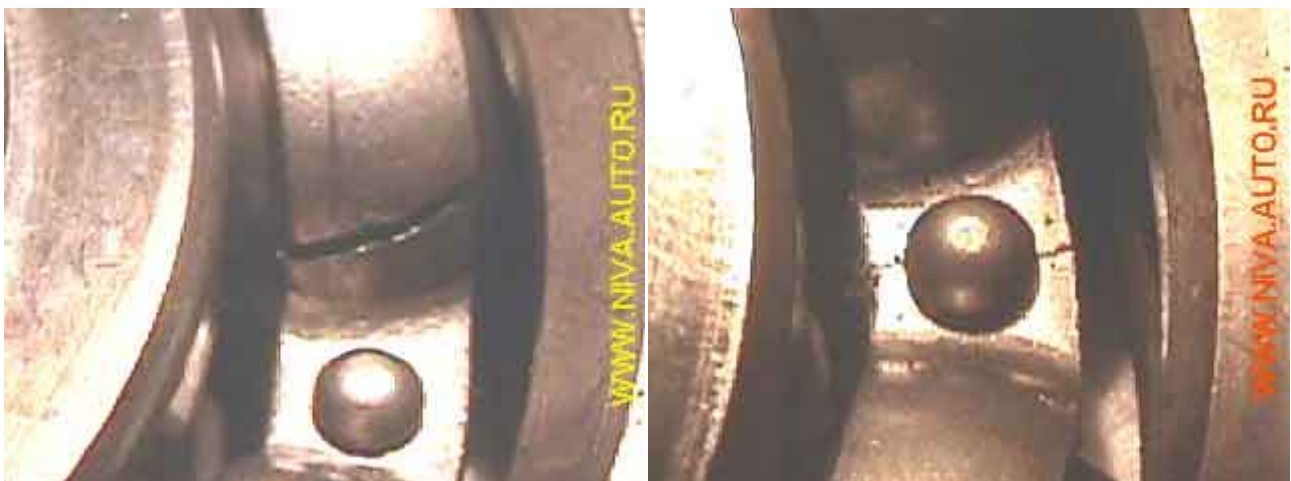
Search the ball cages for cracks:

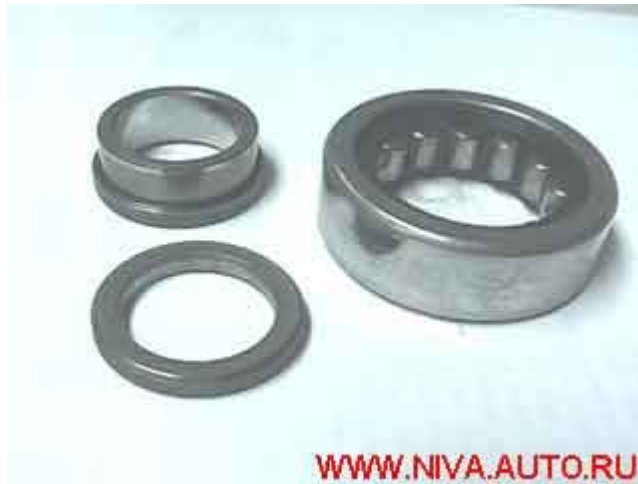
In roller bearings check the rollers for pitting and pale-dark blue coloration:

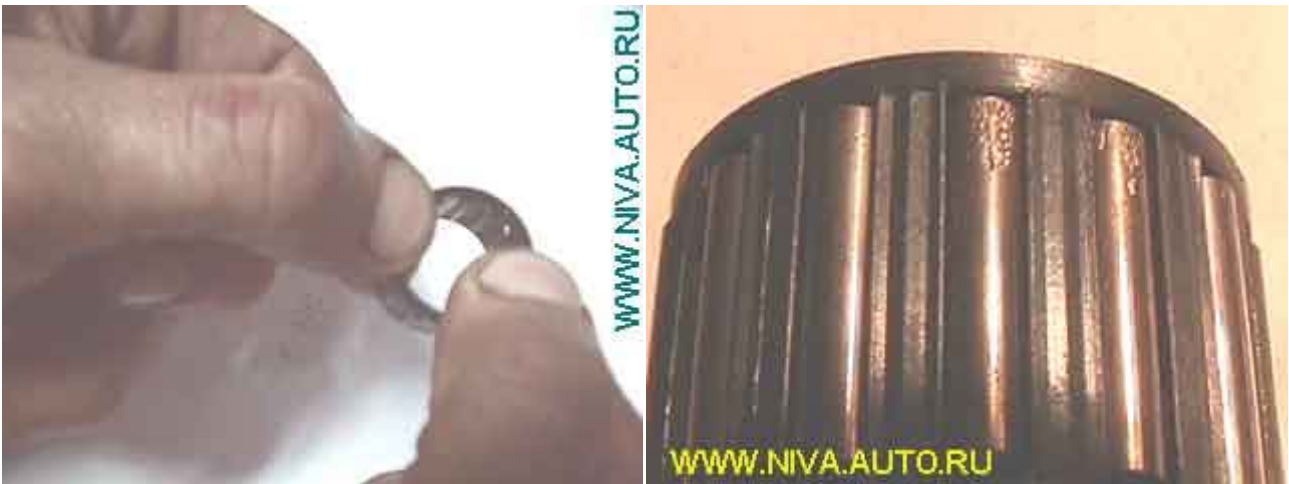
Stretch the plastic needle bearing cage to check its integrity and examine the rollers for pitting or scoring:

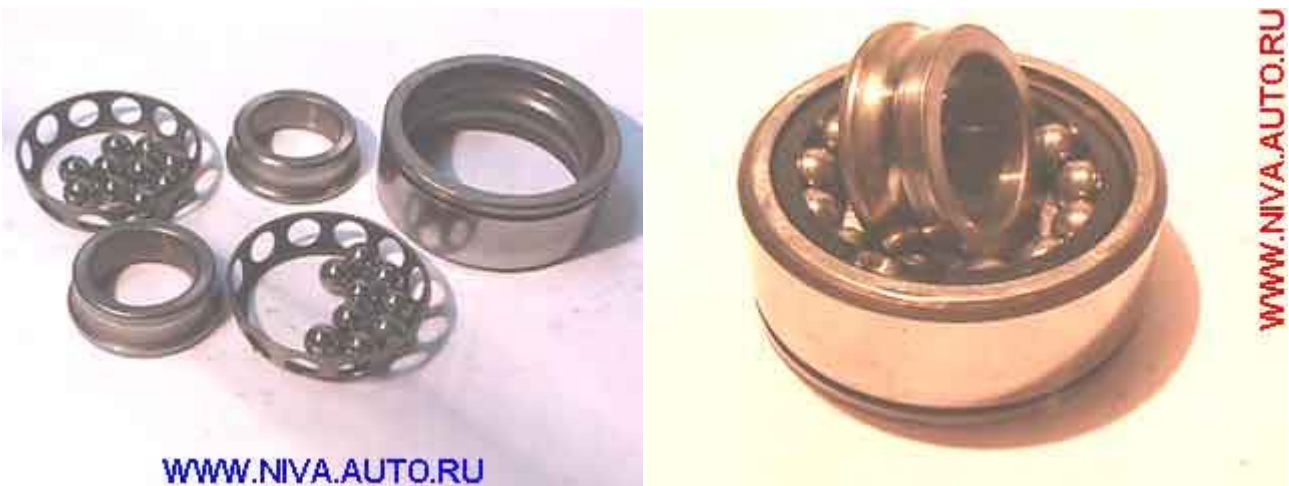
Replace the bearings if there's any sign of play, cracks or pitting. The countershaft's front double-row ball bearing almost always breaks up during the disassembly procedures, so it's replaced by a new one:

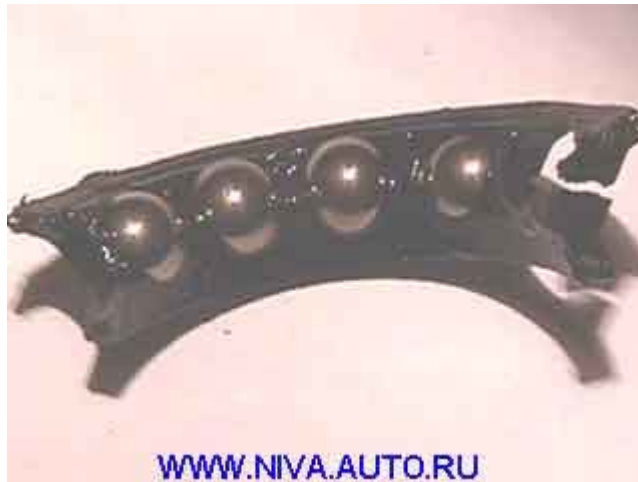
S&#t happens:

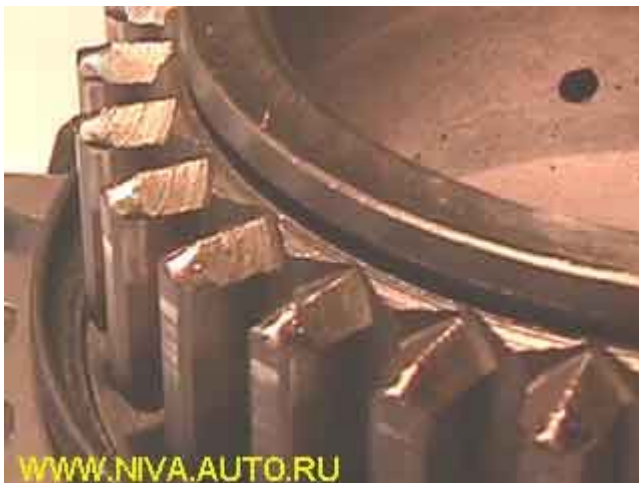
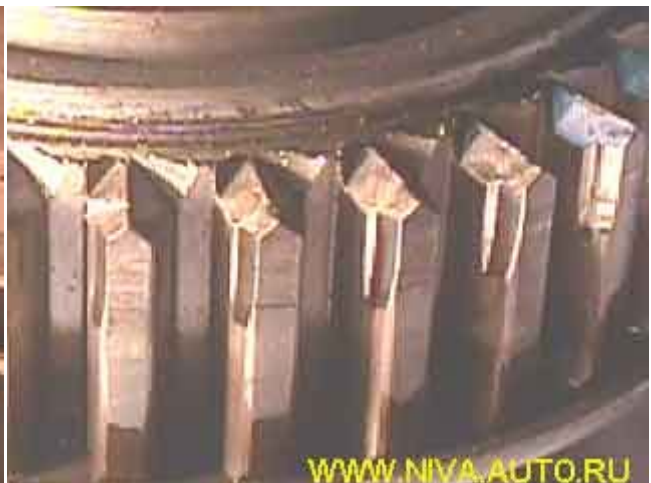
Wash and check all the **gear straight and slanted teeth** are present and bear no signs of cracks in them. The tooth end faces should be sharp, without any deterioration and/or chopped off (as shown on the left picture). Sides should not have traces of deterioration, as shown in the right picture:

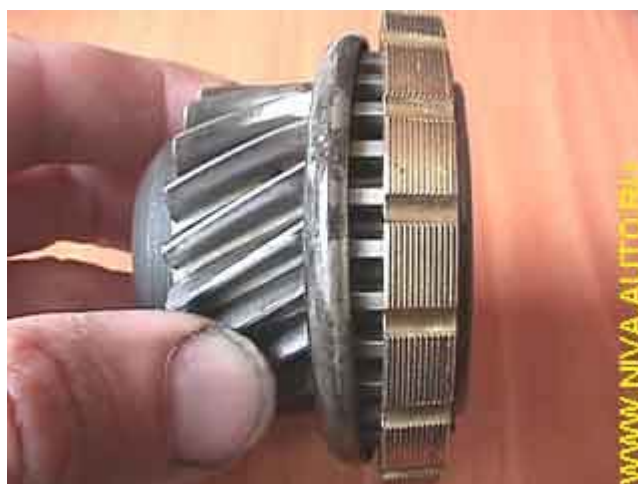
The persistent ring of the synchronizer spring (between the slanting and straight gear teeth) should be ideally equal, and should not be semicircular, warped, oval or dented. This applies particularly to the 5<sup>th</sup> gear (if the gearbox rear nut is loosened, the 5<sup>th</sup> gear sprocket takes the entire load and bends against the 5<sup>th</sup>/reverse gear cluster) the picture shows a 5<sup>th</sup> gear sprocket with a dented persistent ring:

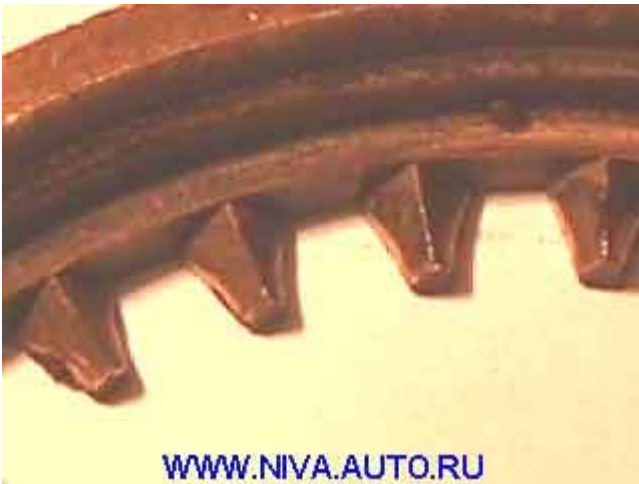
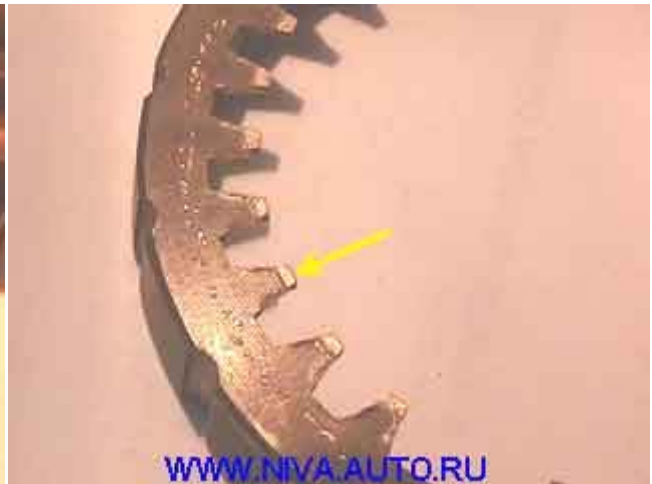
The **synchronizer baulk rings** are cleaned out and examined for deterioration of the tooth tips from both sides:

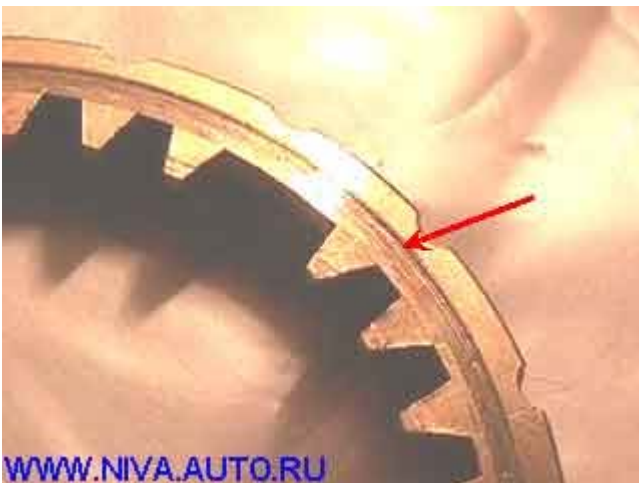
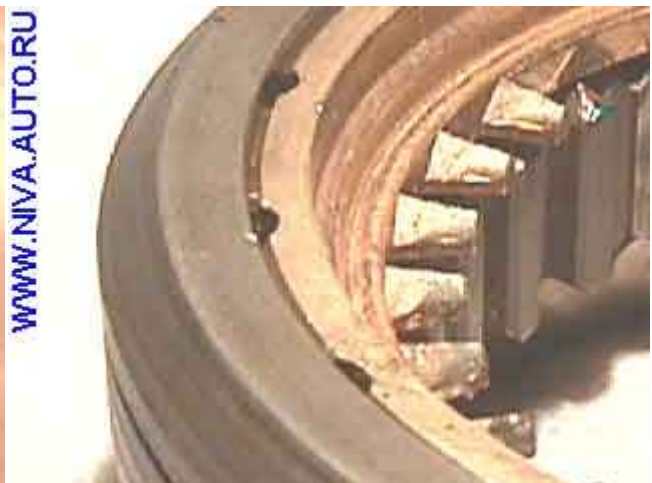
There should not be wear or rub marks on the top part. The left picture shows marks made by contact against the lockring. The marks also tell how strong the baulk ring interacts with the sleeve, in this case the baulk ring sinks deeply and its top face bears against the sleeve teeth (right picture):

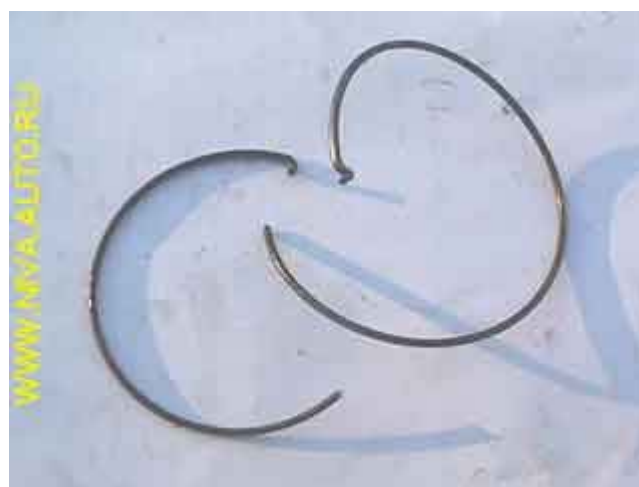
The integrity of the **synchronizer springs** is checked visually:

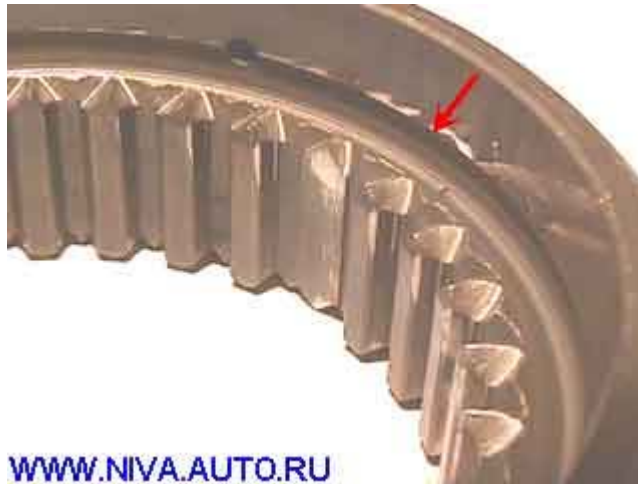
Wash the **synchronizer sleeves** with a hard brush, especially the groove over the teeth where a lot of metallic debris always builds up (shown with an arrow in the picture):

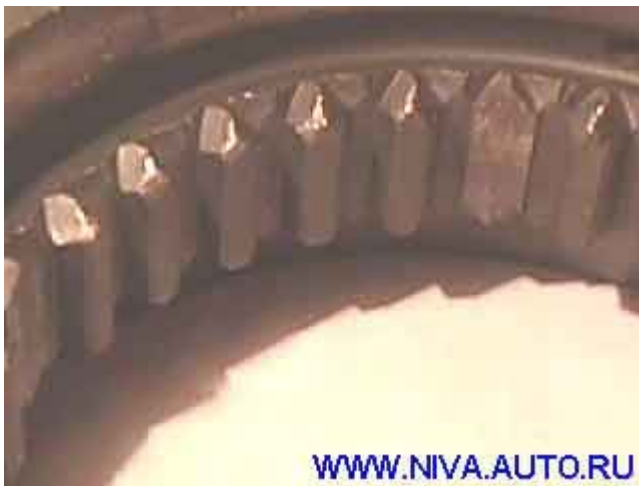
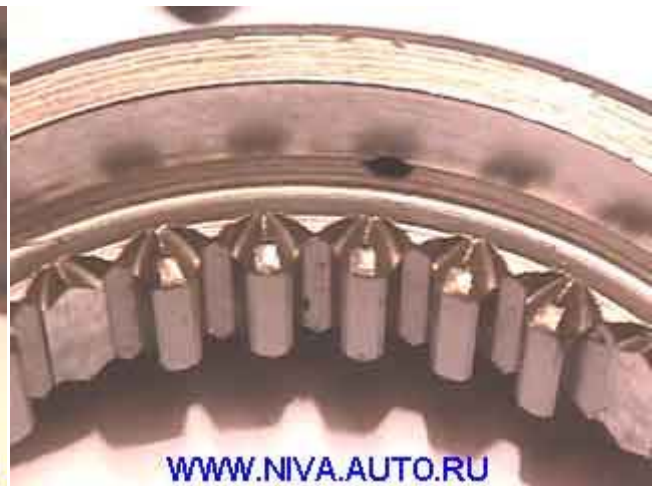
Examine the tooth end faces. They should be sharp without deterioration or chopped off:

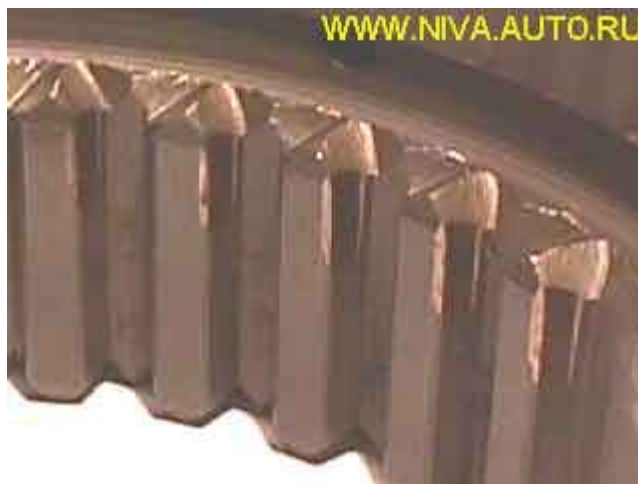
Tooth sides should not have any signs of deterioration:

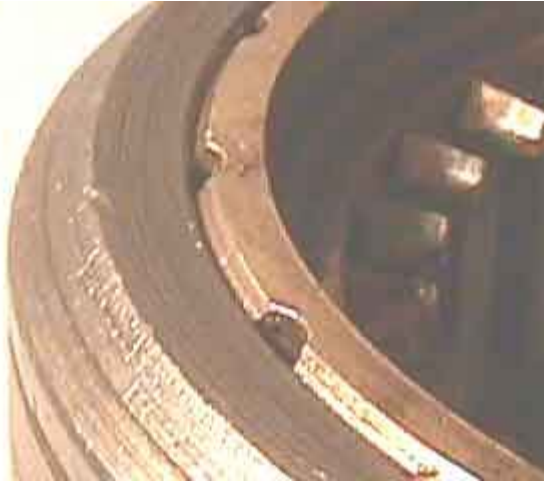
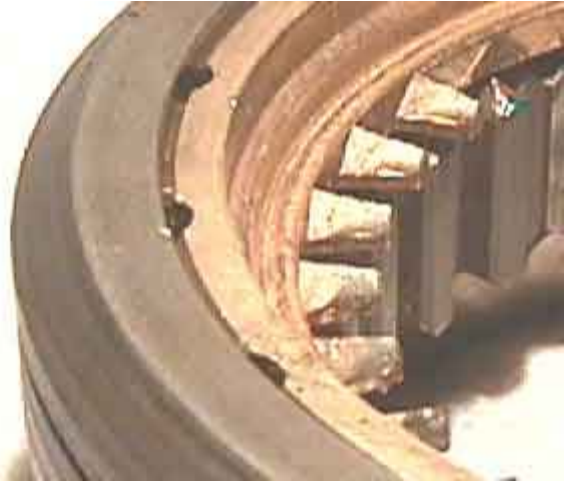
The baulk ring should not sink deeply into the sleeve and touch its teeth as on the right picture:

Worn out sleeves are replaced by new ones.

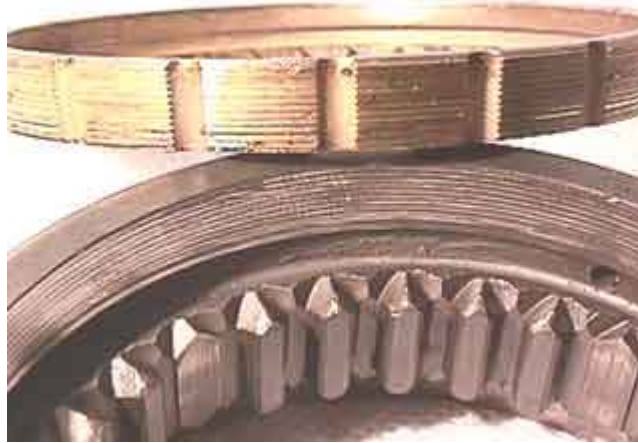
Also the working surface of the sleeve should not have any scores made by the baulk rings:

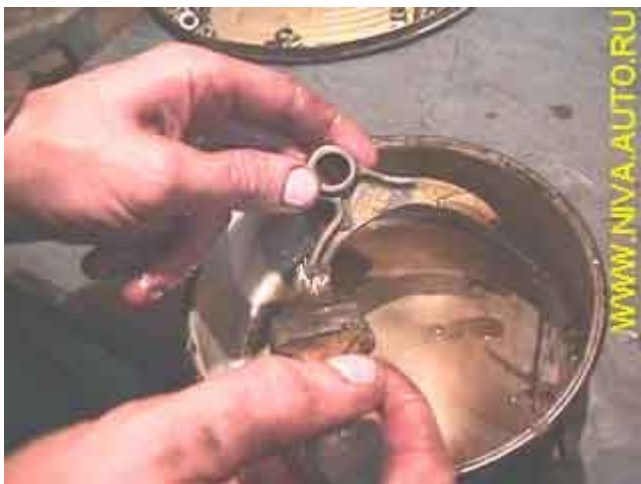
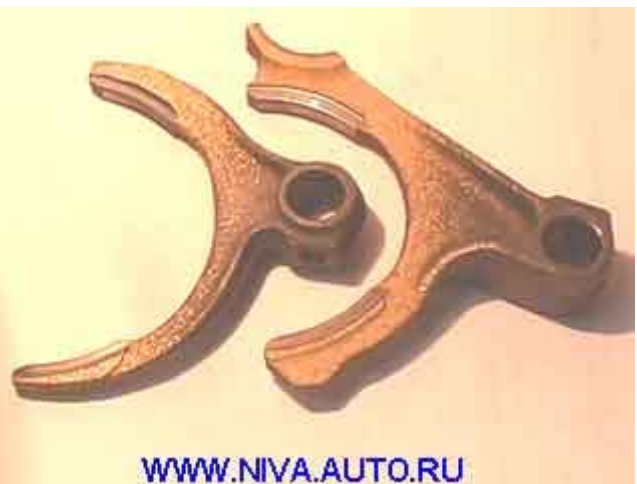
Wash from oil and wipe the **shift forks**. They should not have signs of wear or damage on the working surface:

Worn out forks are replaced by new ones.

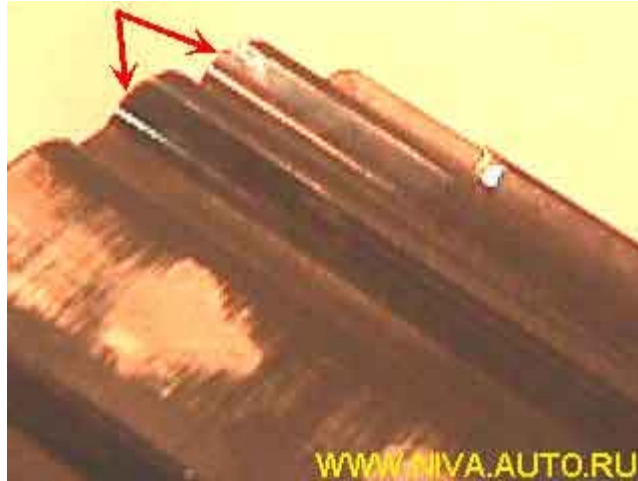
Wash out the **gear hubs** with gasoline and check their splines for damage:

Faulty hubs are replaced by new ones.

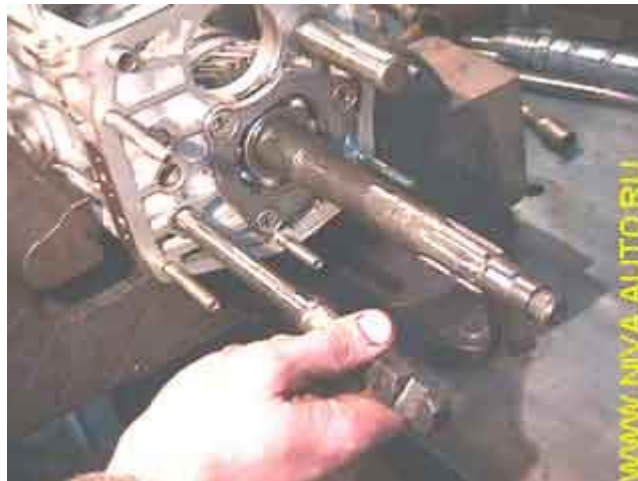
Check the **shift rails** for ease of movement in the gearbox case:

Also check the condition of the detent mechanism surfaces and the shift gates (where the shifting mechanism works). Faulty rails are replaced by new ones.

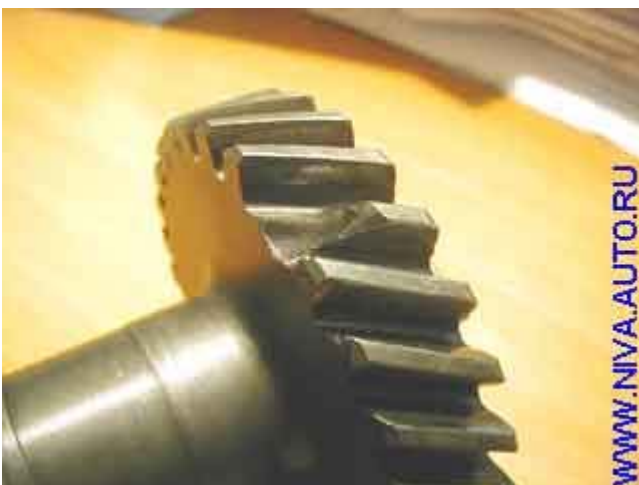
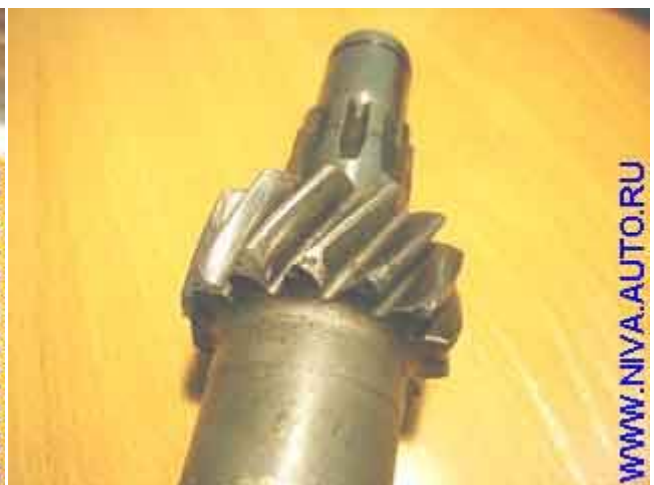
The **countershaft** gears are examined for integrity of the teeth and absence of cracks on them:

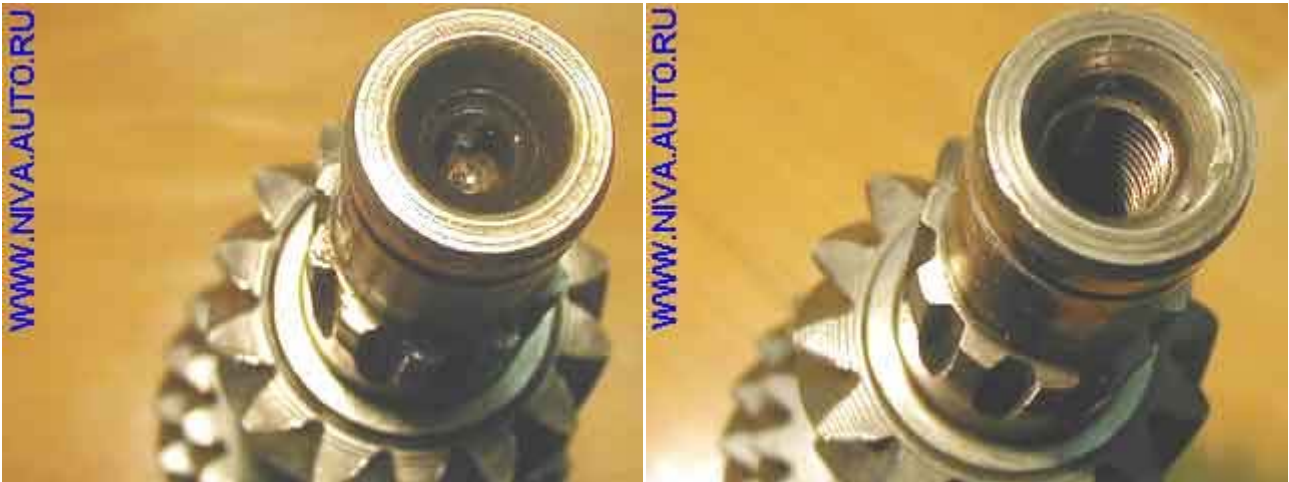
Check the condition of the front and rear end threads. Note (on the left picture) that the 4-speed gearbox countershaft rear end isn't threaded:

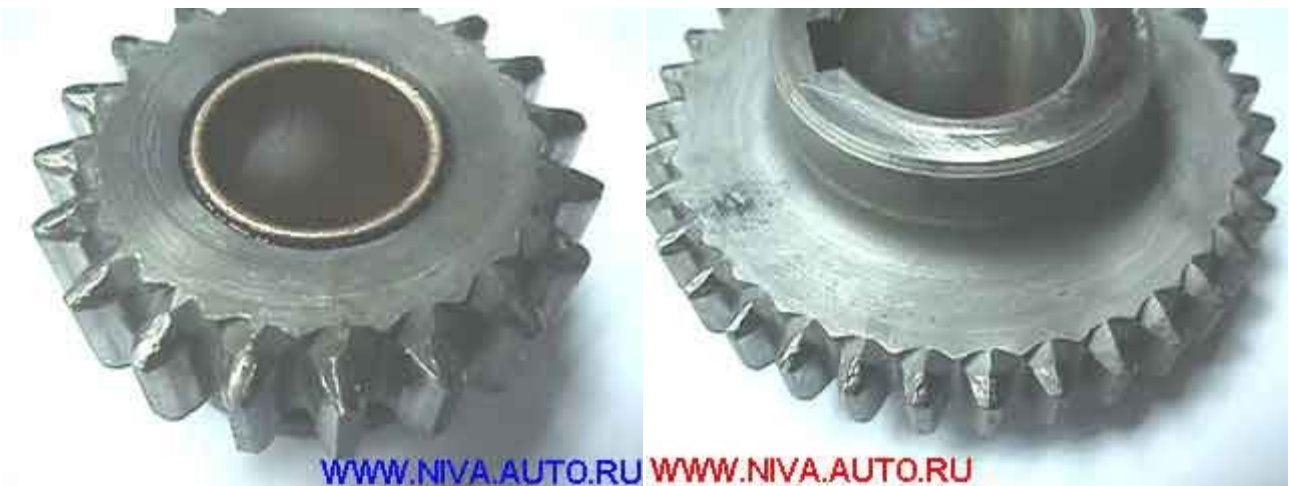
The **reverse idler and drive gear** should have sharp tooth end faces. Any gears with worn out teeth are replaced by new ones:

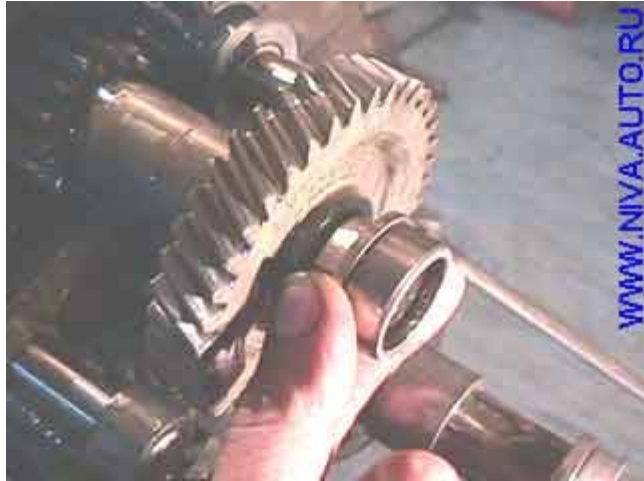
The **5<sup>th</sup>/reverse gear cluster** is checked on presence of all teeth (sometimes the slanting teeth break up) and absence of cracks on them. Also check the small sprocket for damage on the end faces. The bearing inner race should not be removed by the hand's force:

A faulty gear cluster is replaced by a new one.

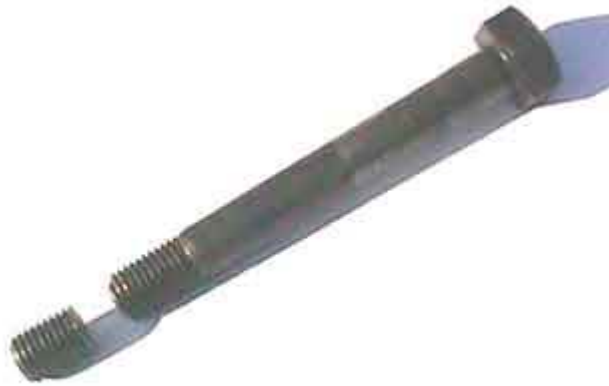
The **gear cluster bolt** breaks up rather frequently:

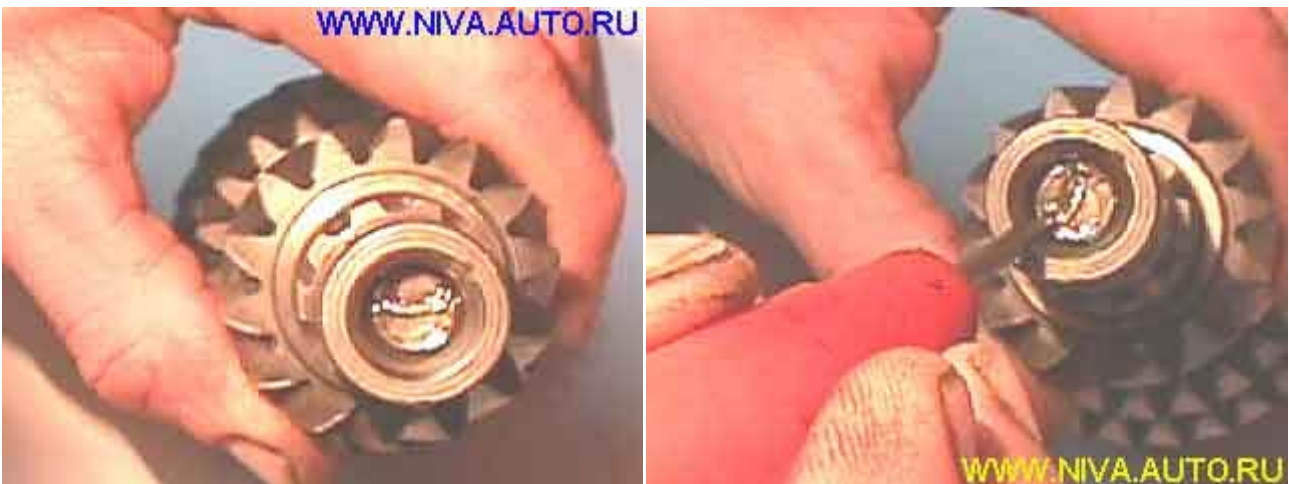
One time I broke this bolt during tightening with the torque wrench. The broken bit remains in the countershaft; but it can be removed easily with a small screwdriver and a little patience:

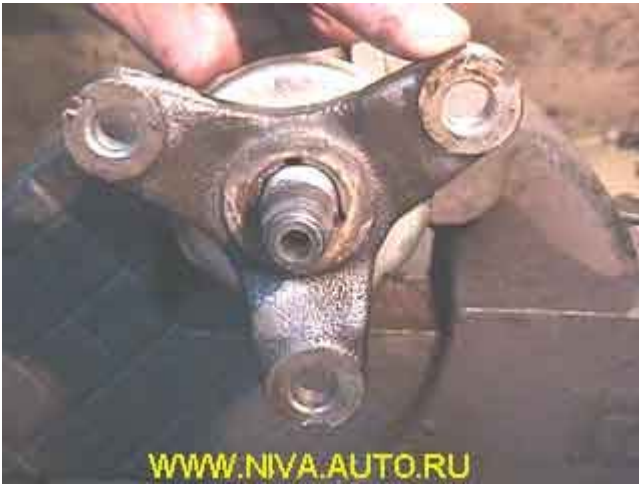
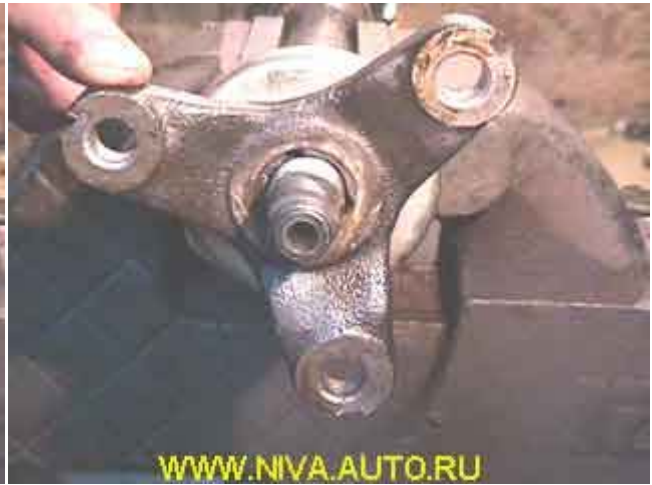
The **main shaft** fails extremely seldom. Nevertheless, check if there's any play between the shaft and the output flange splines:

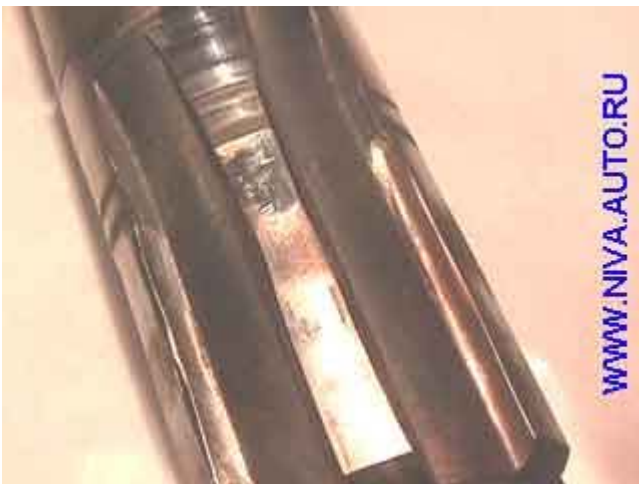
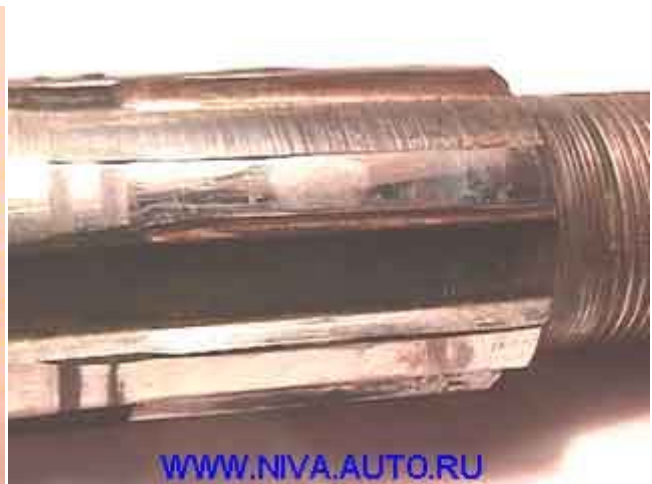
In my practice I found a case where the main shaft splines were damaged. On the left picture it is well visible how the splines were narrowed down. This was the result of a quite negligent attitude (operating the gearbox with a loose rear nut):

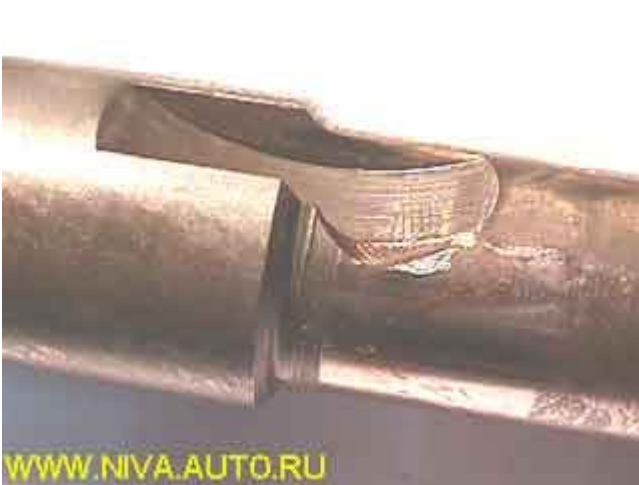
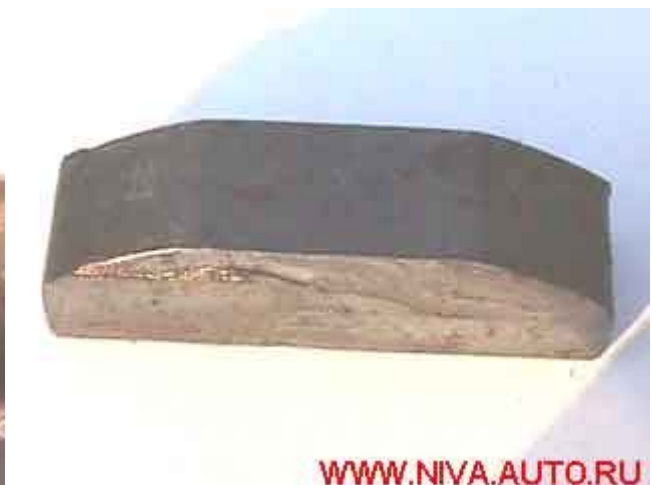
Examine the Woodruff key and the main shaft keyway:

If there's any play between the key and the keyway replace the key or the main shaft as needed.

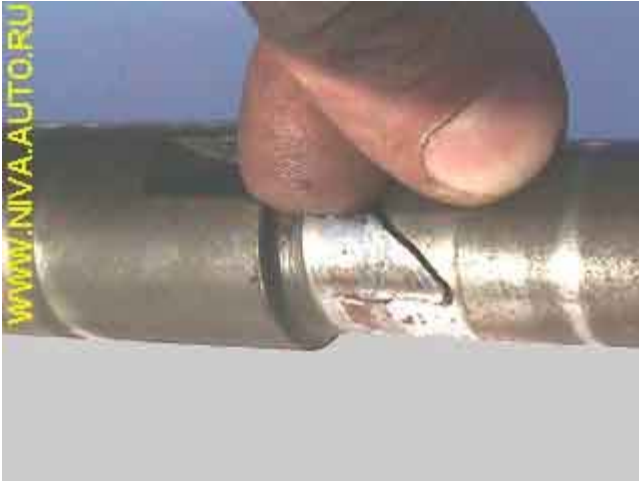
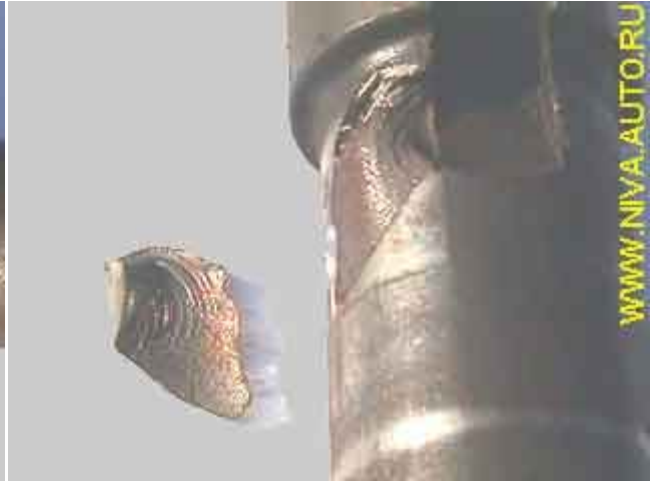
Sometimes is possible to find surprises just by lifting with your fingernail:

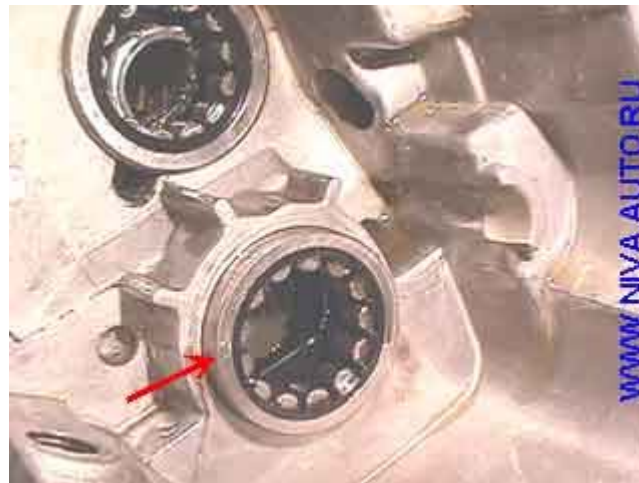
The **gearbox rear cover** must be cleaned of any oil and metal fragments. Check the bores of the bearings of the main shaft and countershaft. The outer bearing races must not turn in their bores:

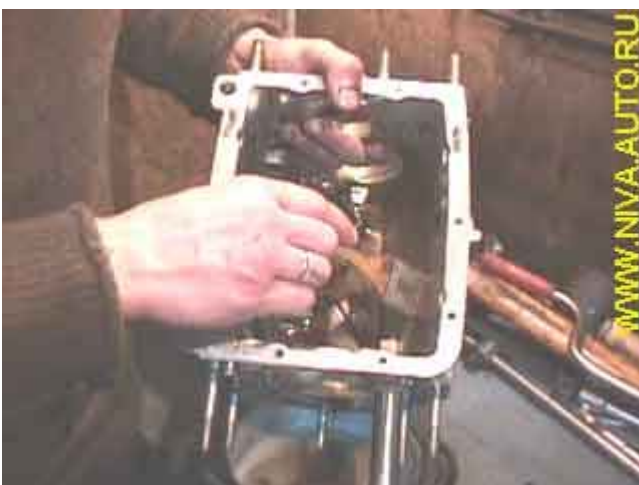
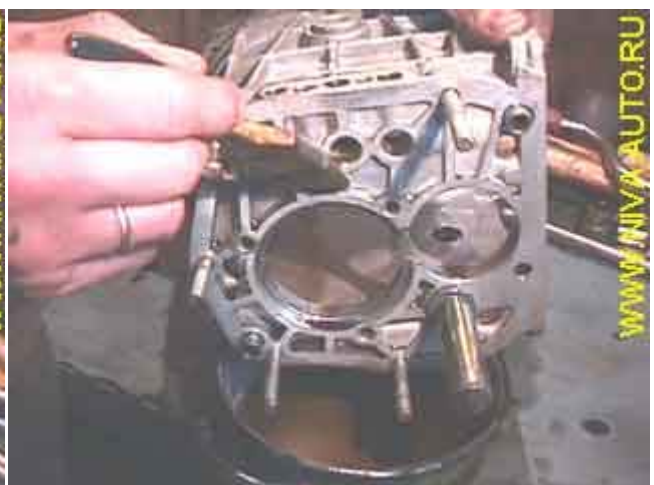
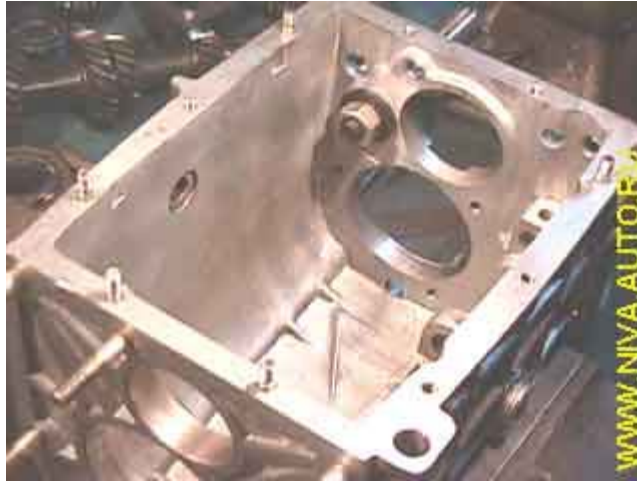
A lot of fragments and debris accumulates in the **gearbox case** front and rear and between the casting reinforcement ribs. Wash all the case thoroughly:

Check the bores of all bearings for scoring or cracks. The bearing outer races should not be turned in their bores. A damaged case is replaced by a new one.

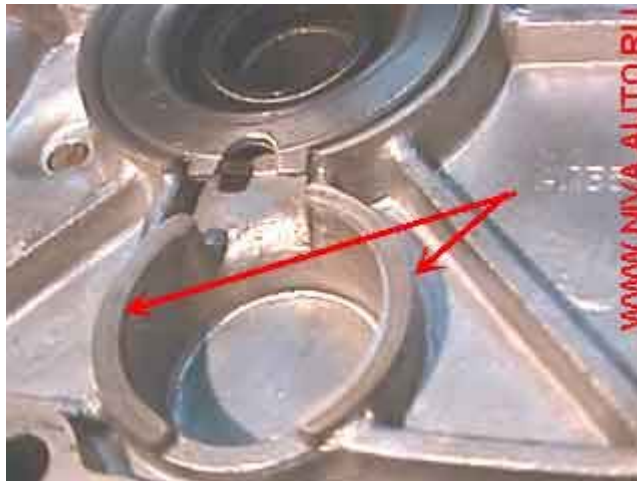
A lot of junk accumulates also in the **bellhousing**, like fragments of the spring washer and/or the input shaft bearing. Therefore I must be washed thoroughly to check its condition. If the front countershaft bearing has been completely destroyed pay attention to the condition of the bearing clamping tabs (shown by arrows in the picture):

If these tabs are damaged the complete bellhousing must be replaced.

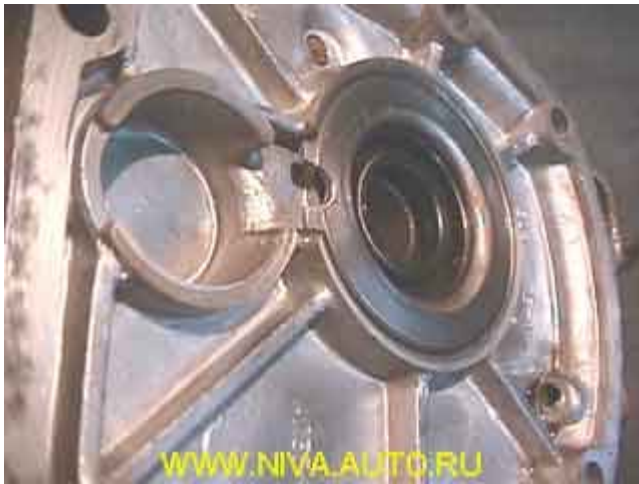
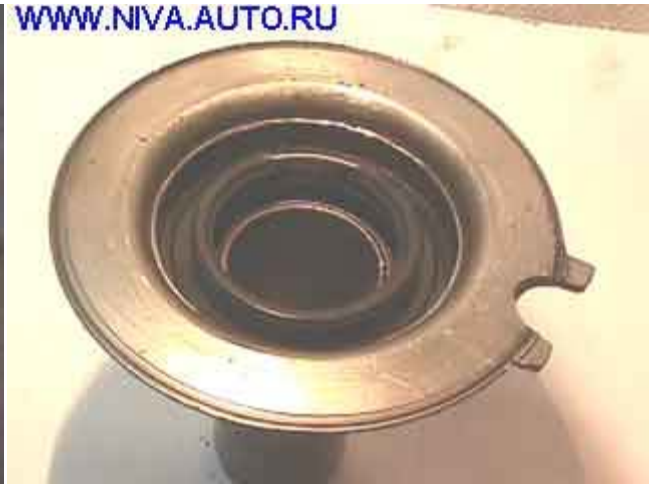
Inspect the **clutch release bearing guide tube**. If it shows a deep groove made by contact with the spring (thrust) washer or can be removed easily from its place by hand force replace the guide tube:

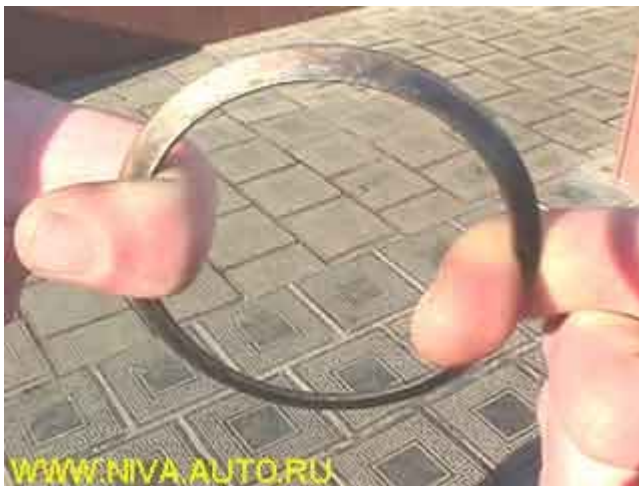
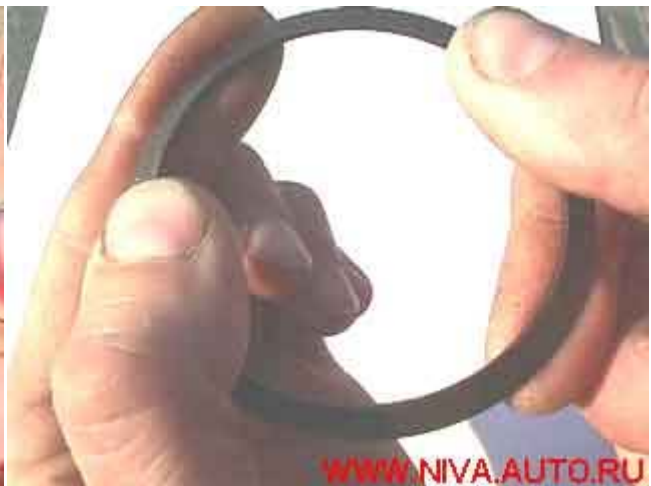
The **spring (thrust) washer** is checked by stretching and twisting:

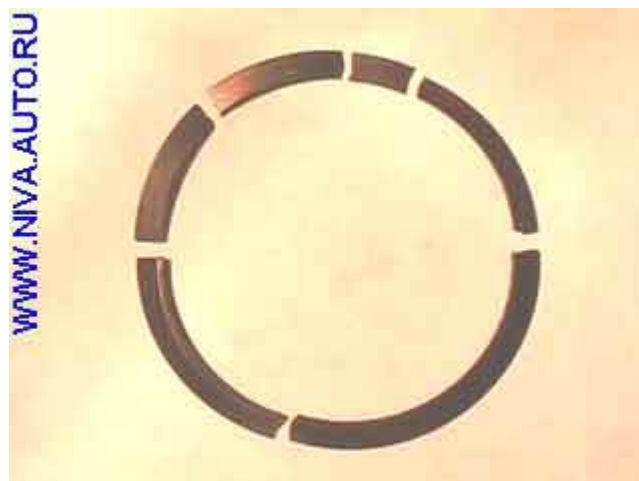
A warped, damaged or broken washer is replaced by a new one:

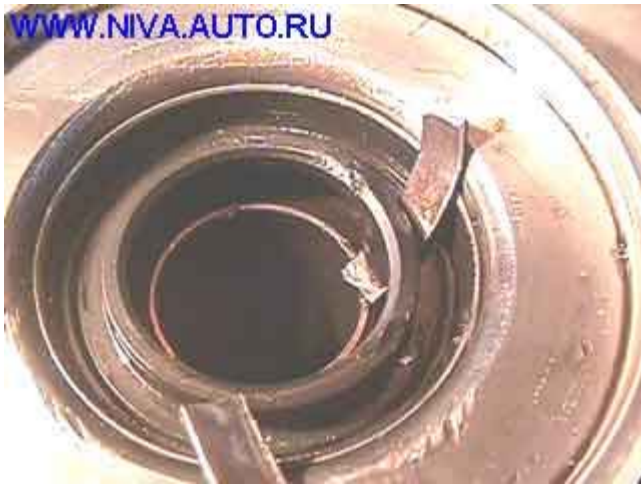
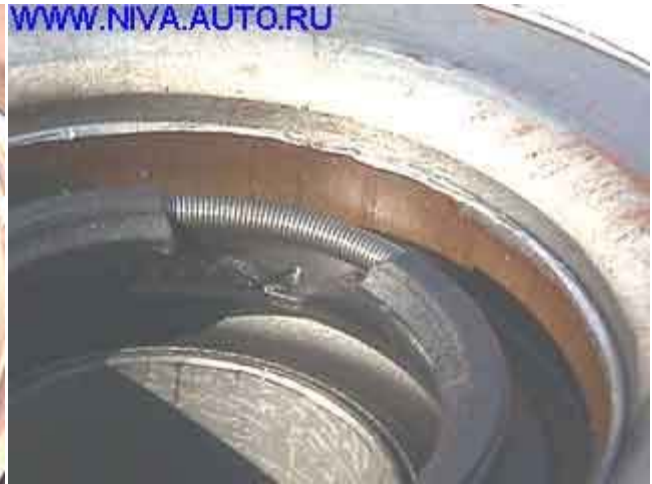
Check the **oil seals** for damage and cuts on the rubber lip:

The seal working edges should be not more than 1 mm in width.

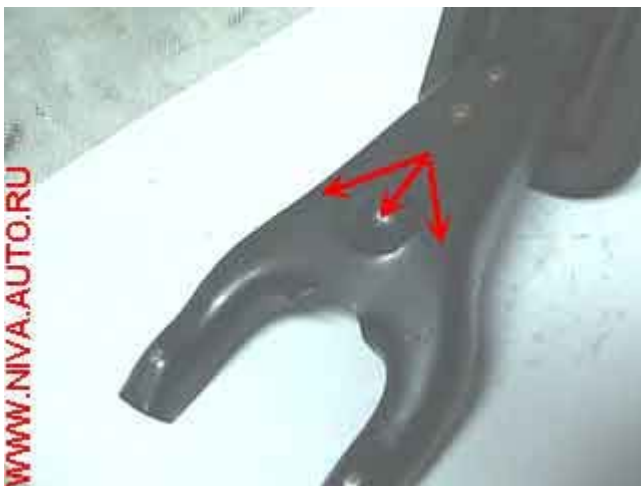
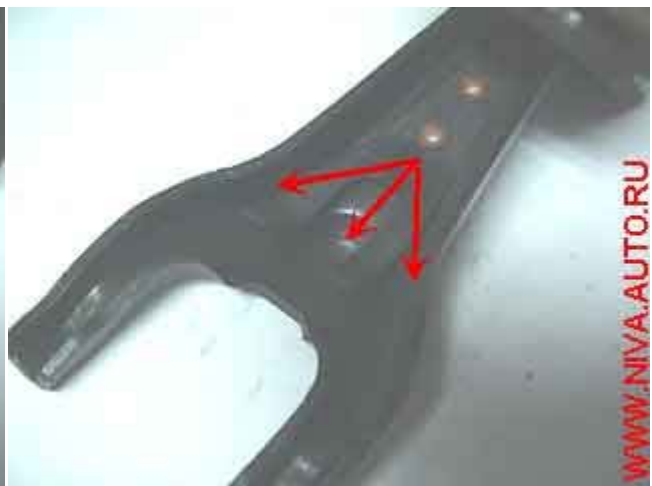
The **clutch release bearing fork** must be checked for cracks and damage on the places shown by the arrows:

A cracked or worn out fork is replaced by a new one.
