The table of defects

This section depicts the defects all the different gearbox parts might present, aided with a graphic description of the many different malfunctions. Only malfunctions directly linked to the gearbox are described here. Similar conditions can be caused, in some cases, by malfunctions or wrong adjustment of other drivetrain components, first of all, the clutch system.

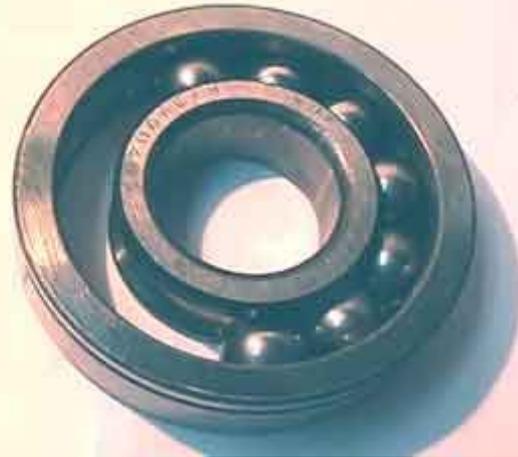
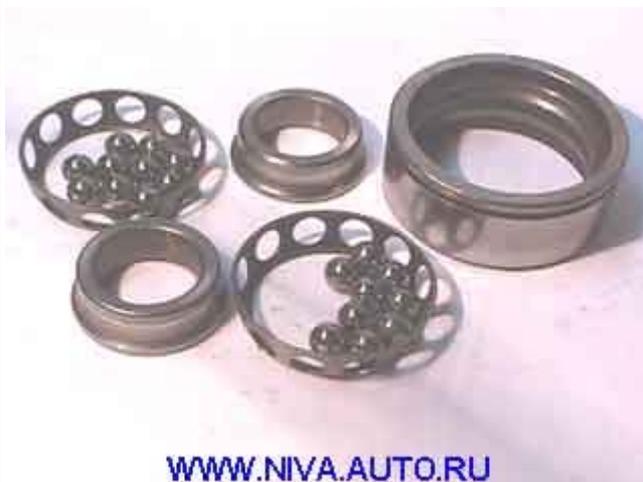
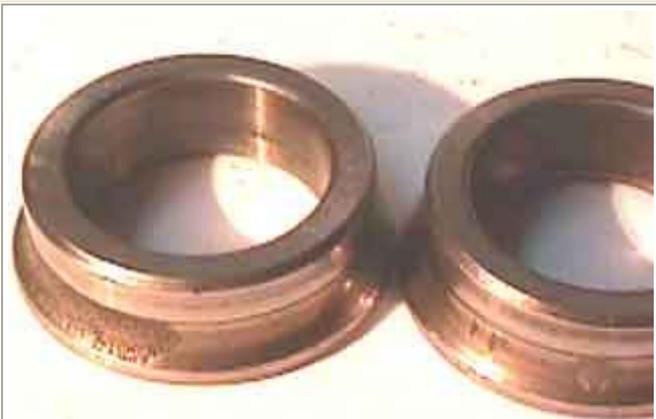
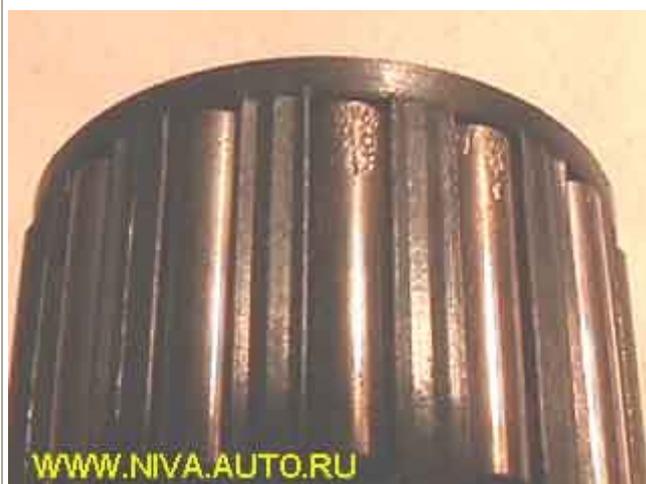
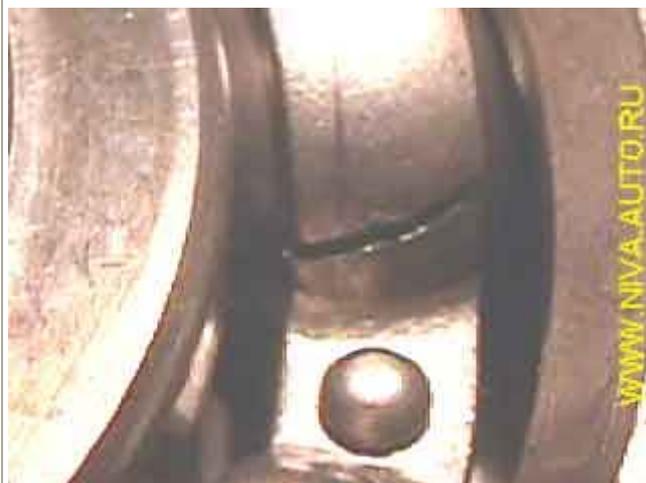
Deterioration and breakage of bearings

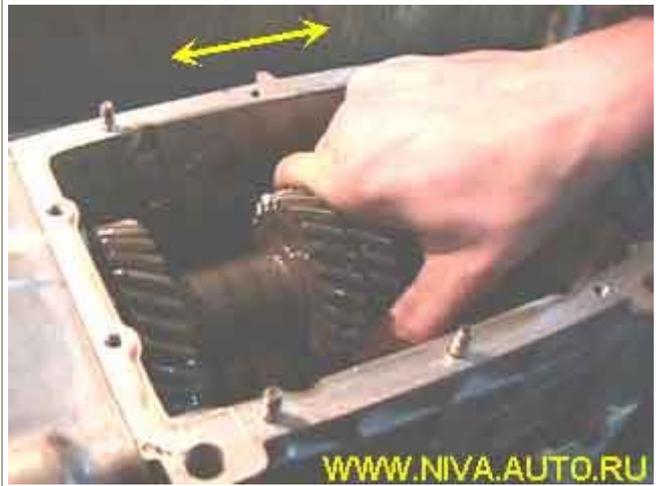
Axial shaft endplay

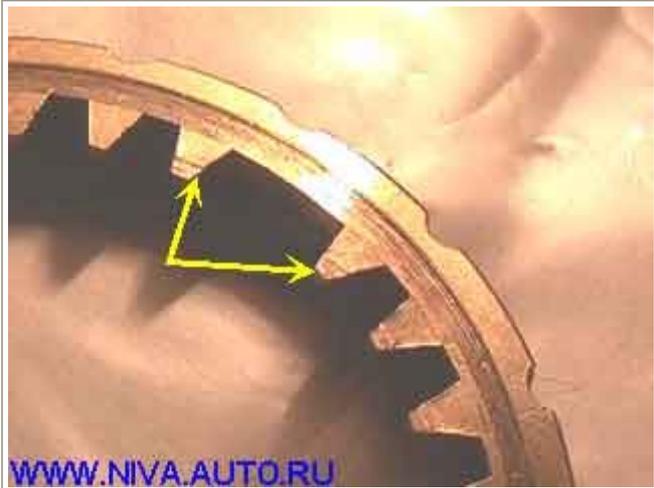
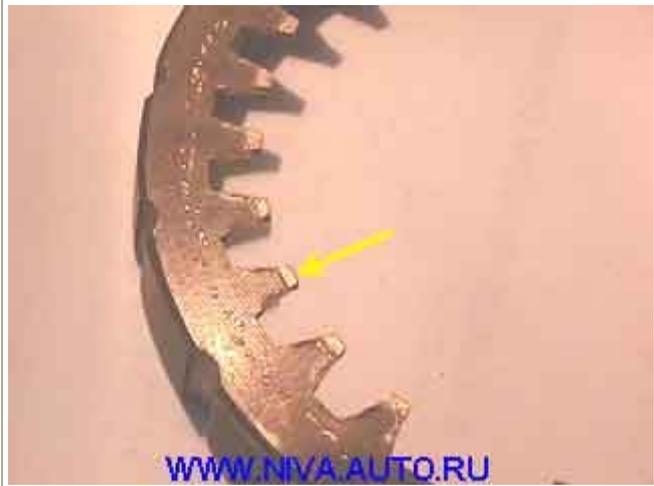
Deterioration of synchronizer baulk rings

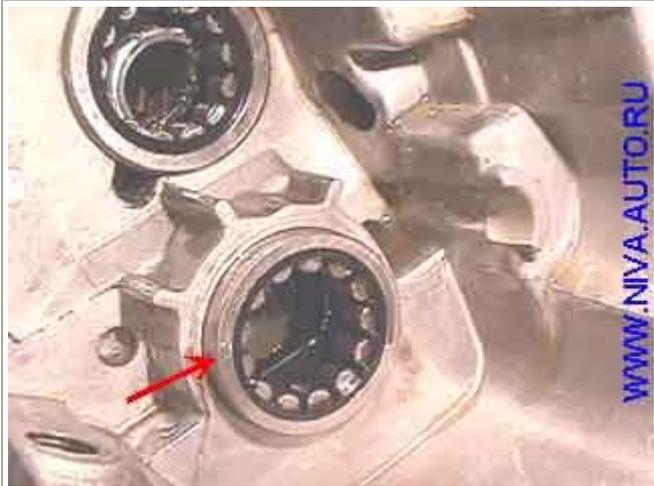
Easy turning of bearing outer races in the rear cover bores

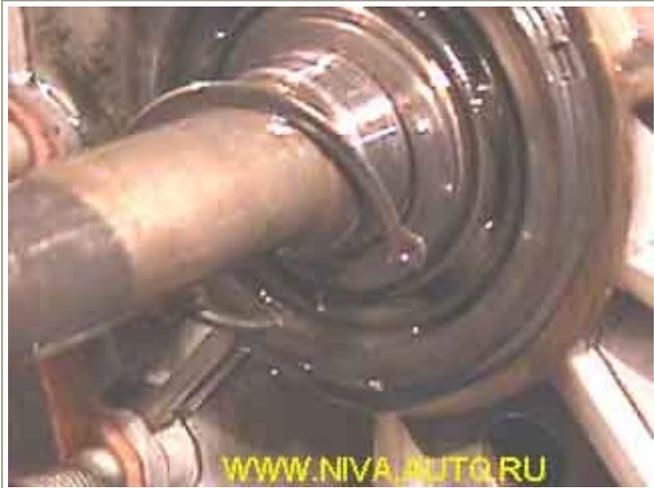
Broken input shaft lockring

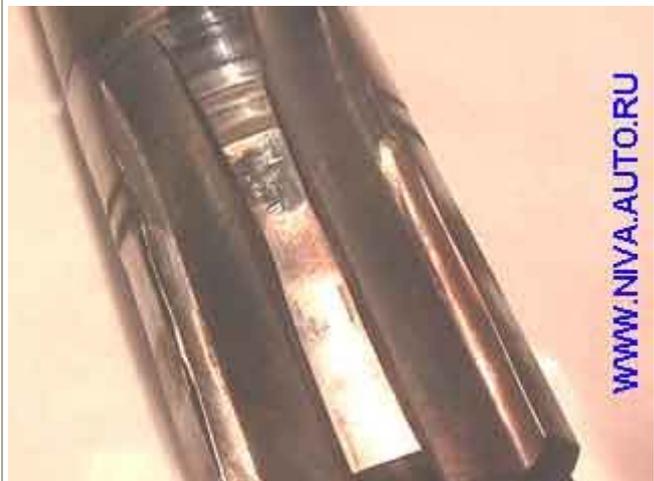
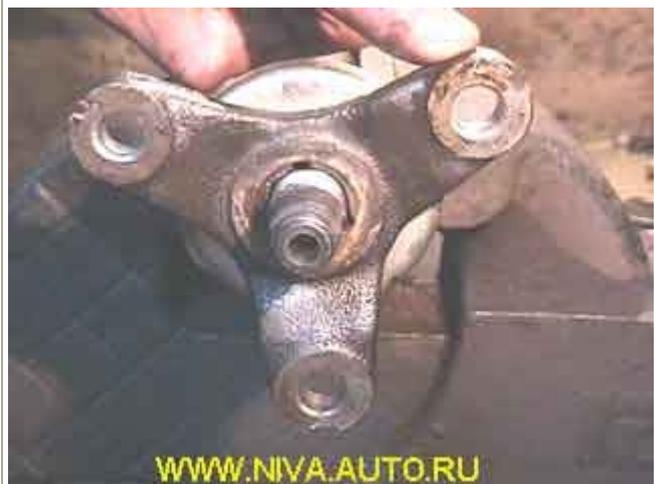
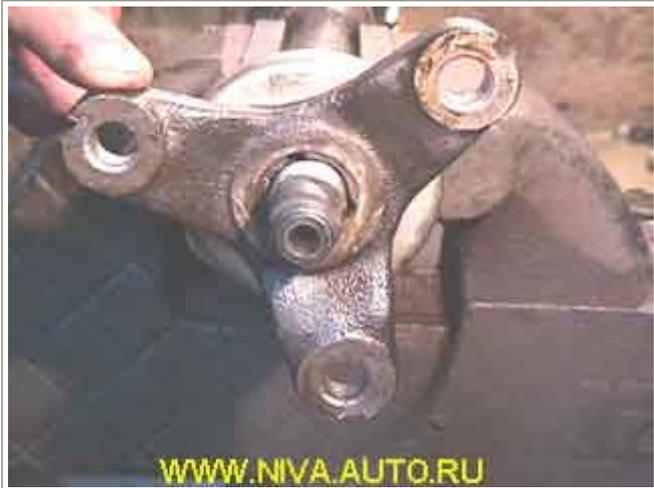
Deterioration of main shaft and/or output flange splines

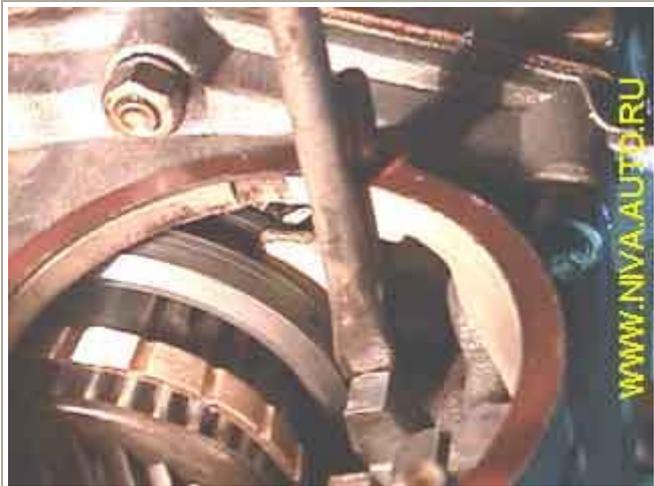
At attempt to shift one gear off has skipped the gear in the fork of the shift rail of other gear

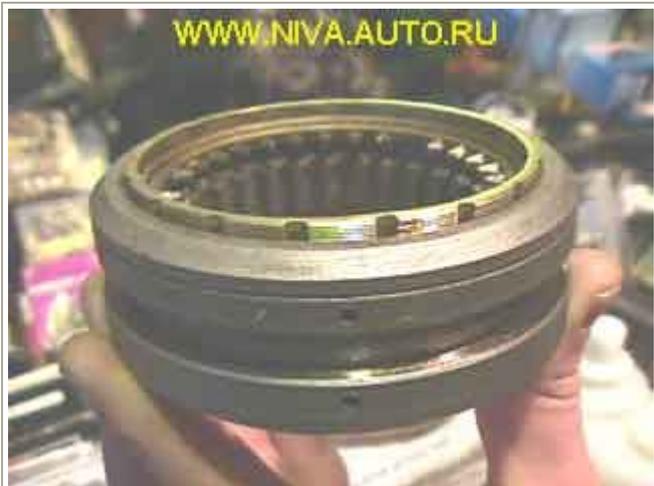
Synchronizer baulk ring jamming in sleeve

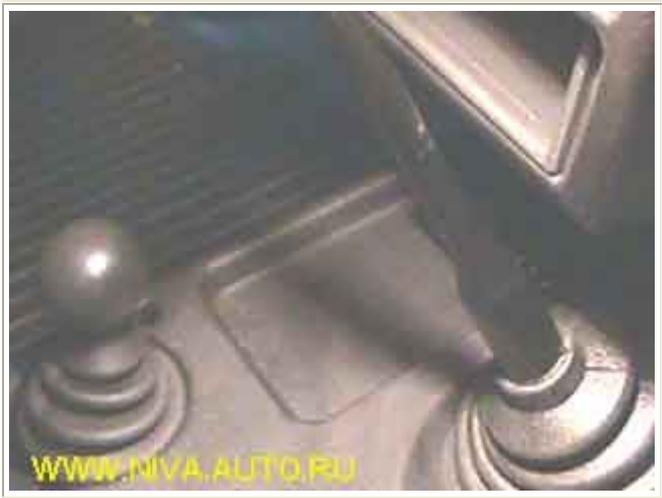
The lever has come off the shifting mechanism

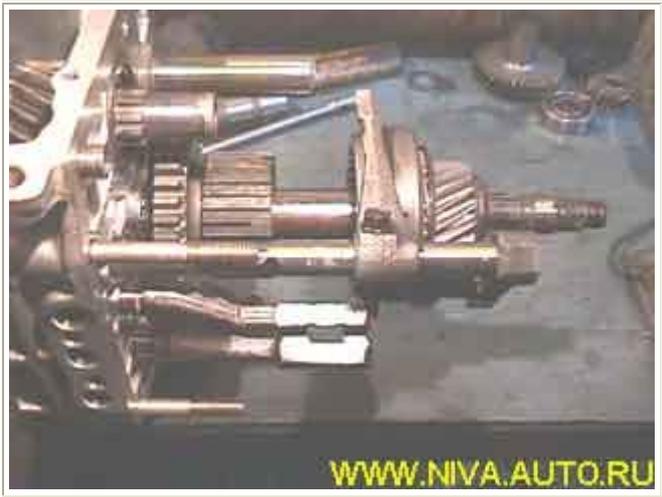
Hard movement of shift rails. In the picture: The rail does not get on its place because the fork is bent to the left

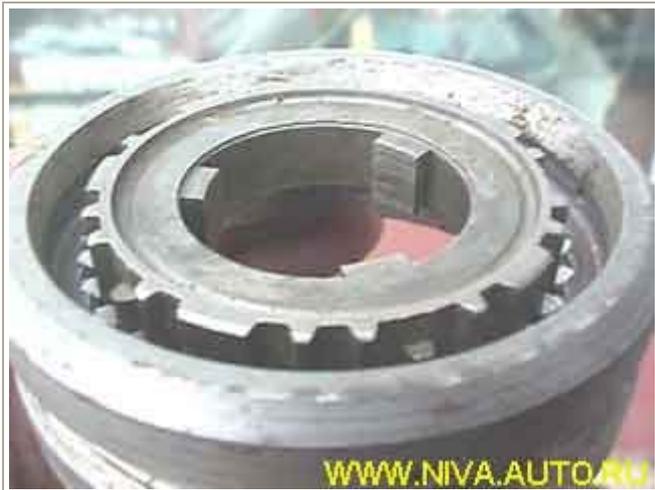
Hard movement of sleeves on their hubs

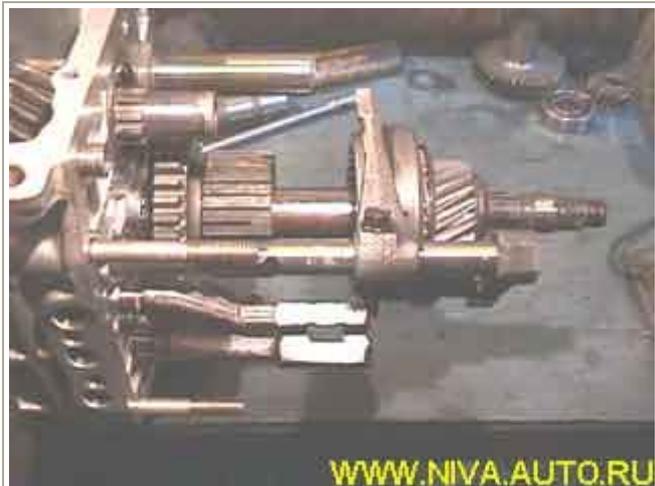
Deformation of shift forks. On the picture it's well visible that the plug is bent to the left and does not land in the sleeve groove

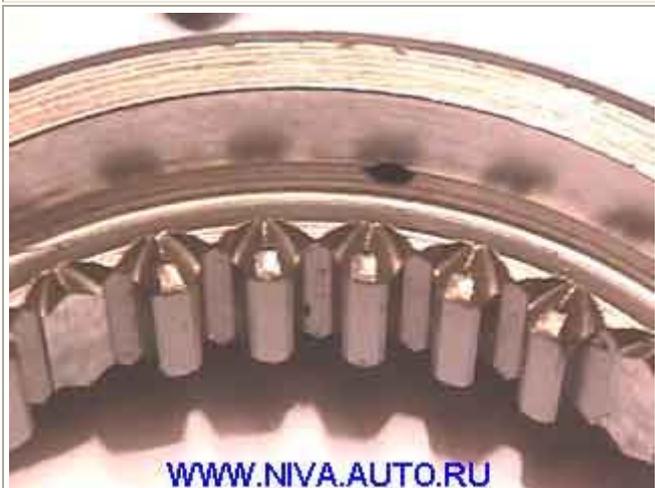
Deterioration of sleeve and gear straight teeth.

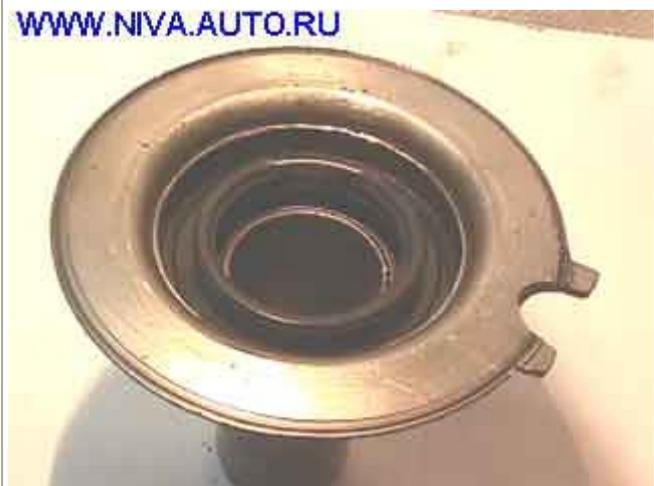
Free moving of the release bearing
directing tube in the bellhousing bore

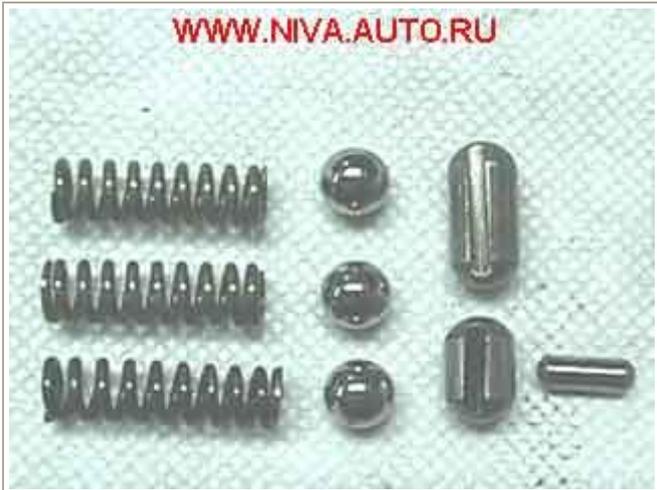
Deterioration of detent balls and/or interlock retainers, breakage or loss of resilience of detent springs

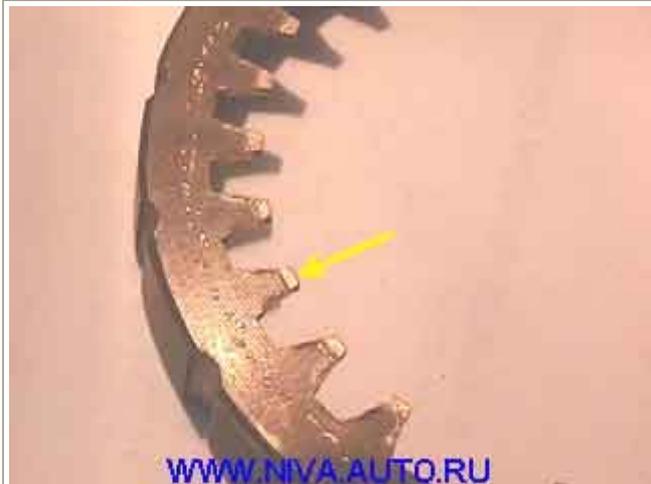
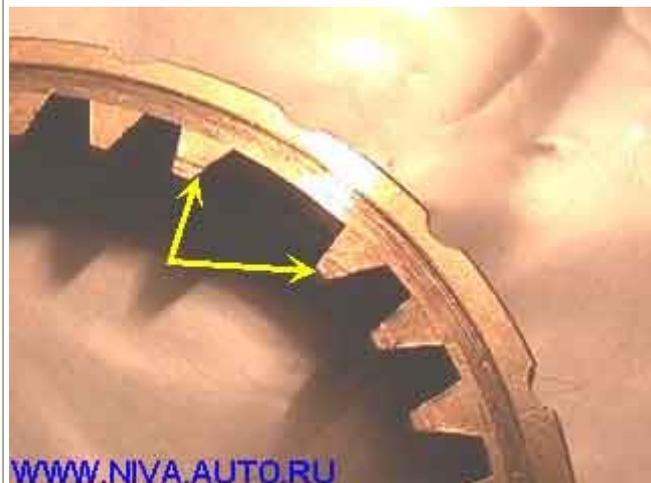
Deterioration of synchronizer baulk rings

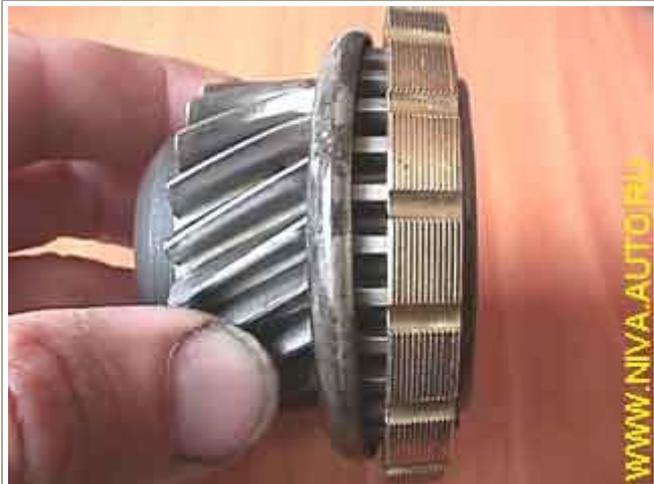
Denting of the synchronizer spring persistent ring. This ring is located between the gear's slanting and straight teeth, note in the picture how this ring is dented aside the straight teeth.

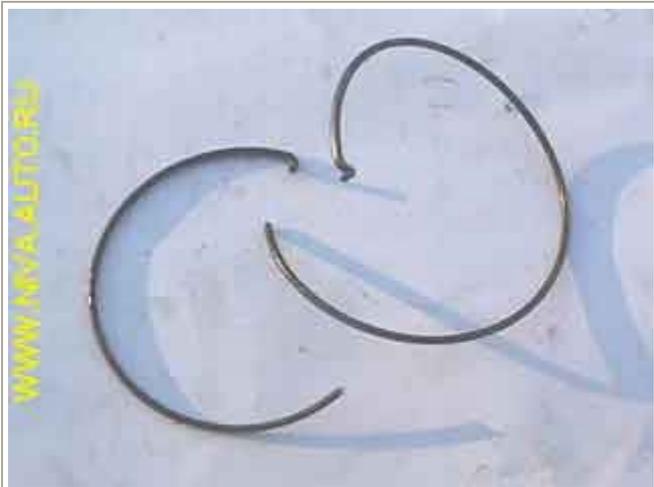
Breakage of synchronizer spring

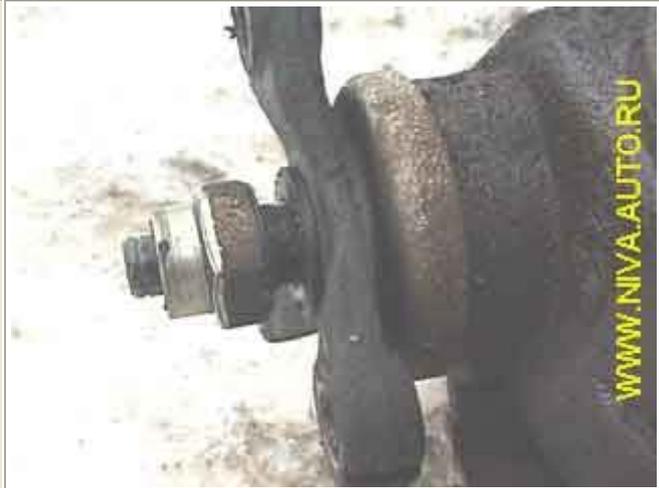
Loose output flange nut

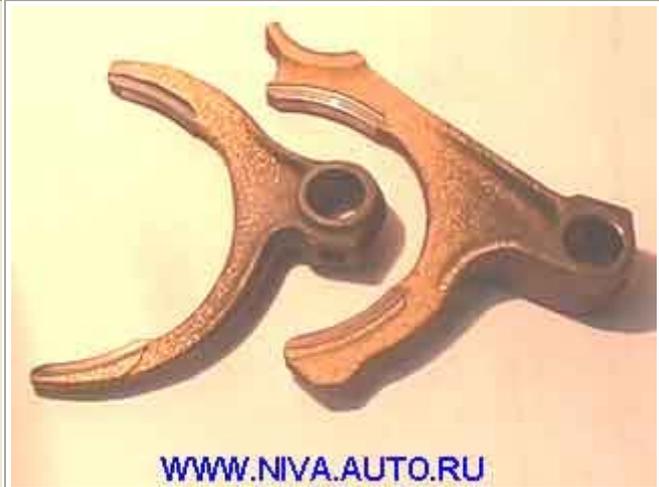
Deterioration of shift forks

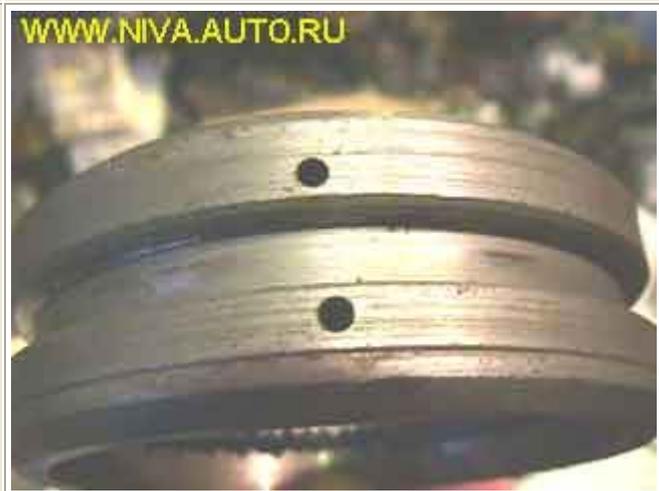
Deterioration of synchronizer sleeve grooves

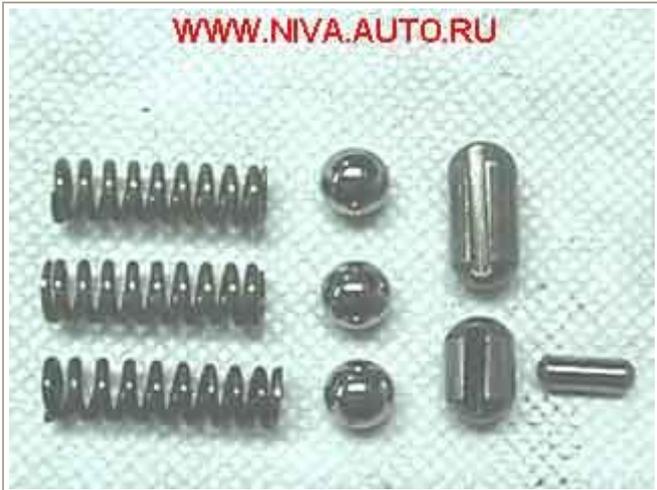
Deterioration of detent balls and/or interlock retainers, breakage or loss of resilience of detent springs

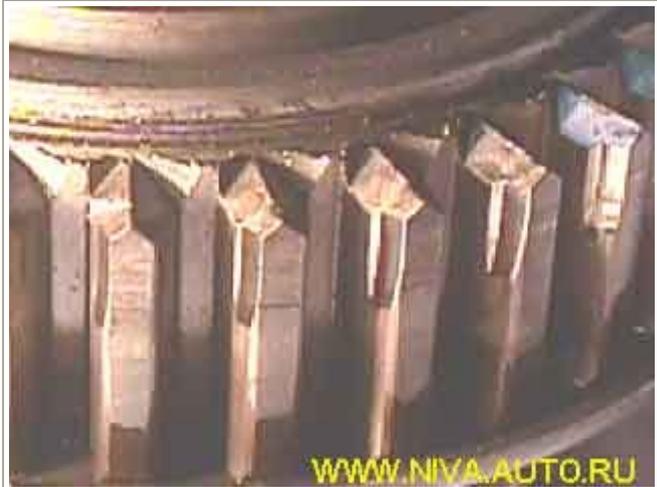
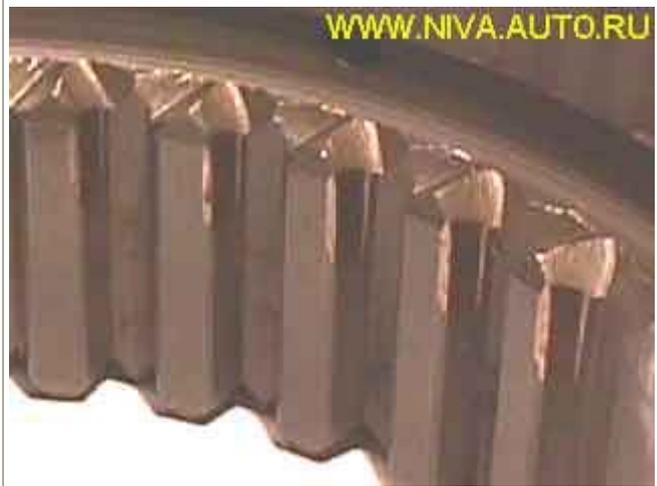
Deterioration of sleeve and gear straight teeth

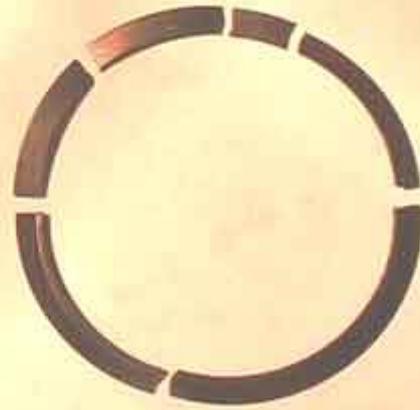
Broken input shaft bearing spring (thrust) washer

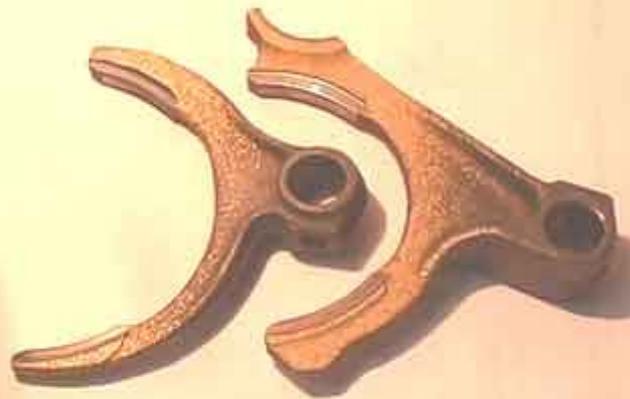
Deterioration of shift forks

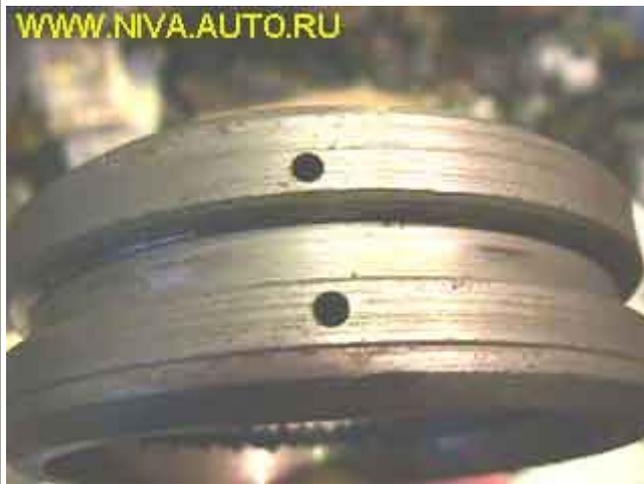
Deterioration of synchronizer sleeve grooves

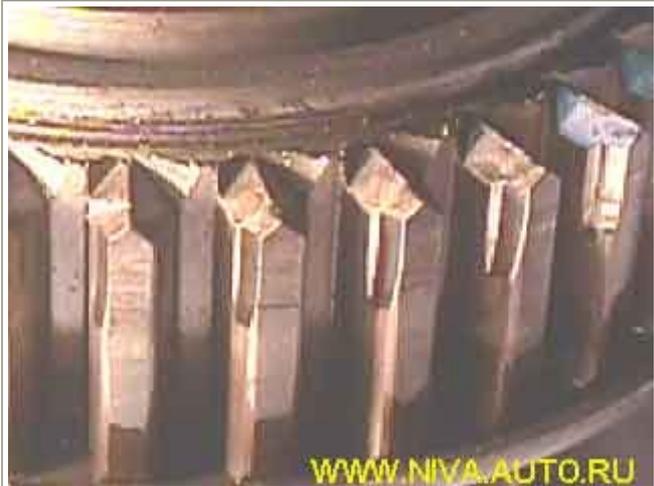
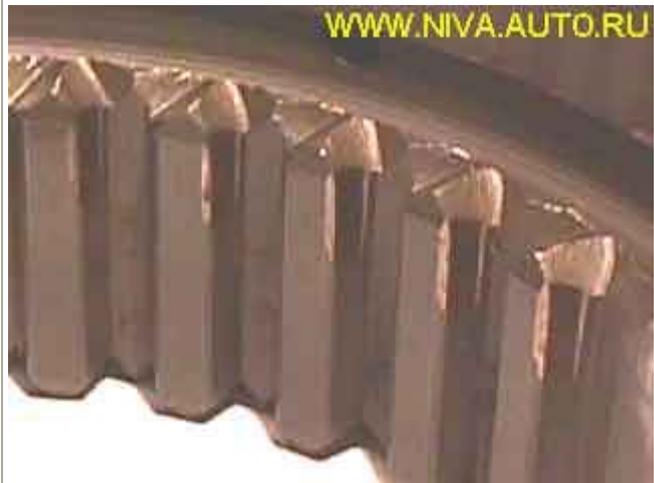
Deterioration of sleeve and gear straight teeth

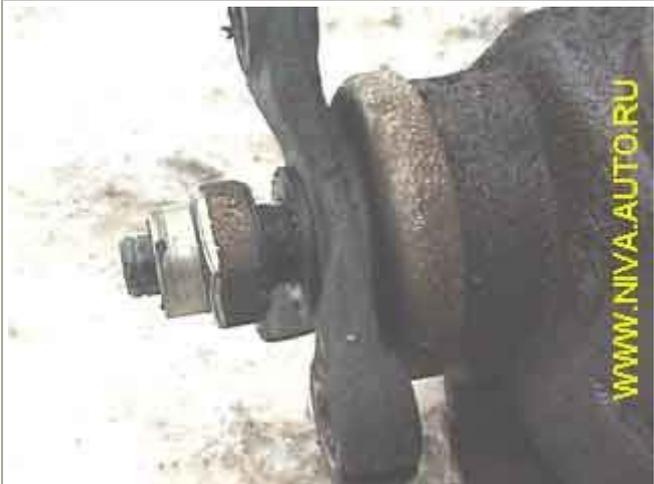
Loose output flange nut

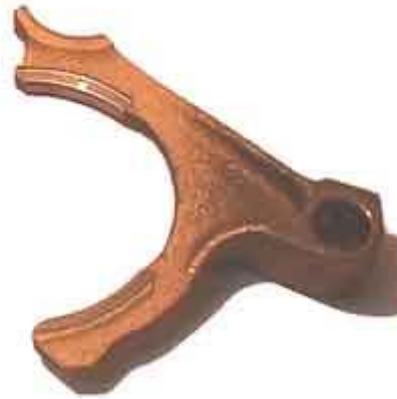
Deterioration of the 5th-reverse gear shift fork

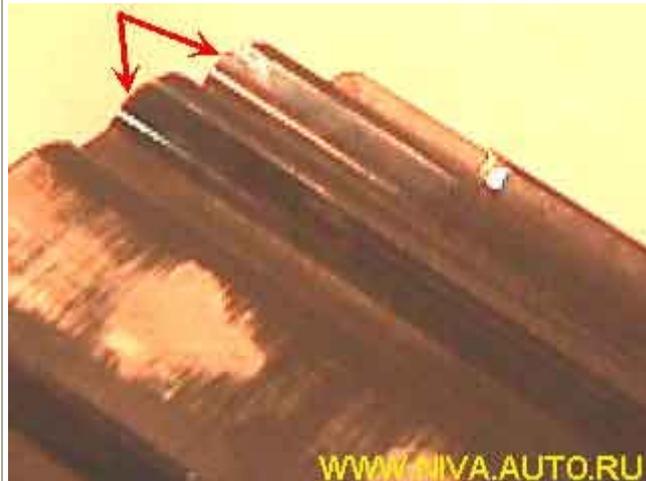
Deterioration of hub splines

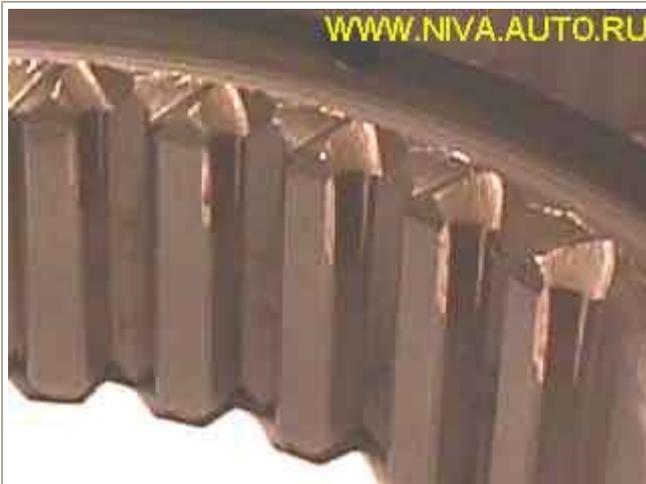
Deterioration of the sleeve straight teeth
(visible from sideways)

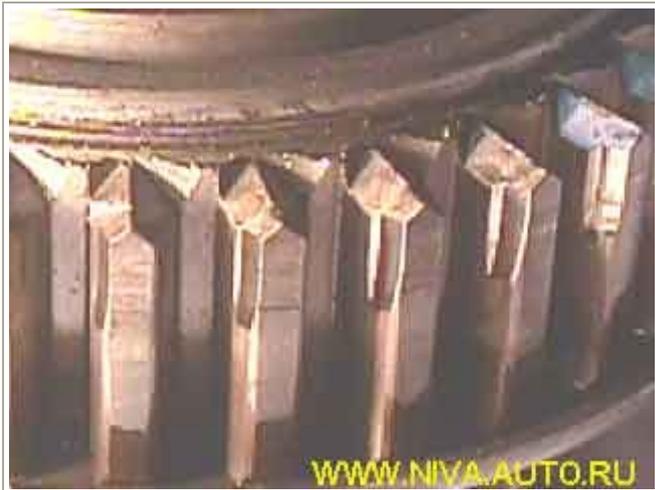
Deterioration of gear straight teeth

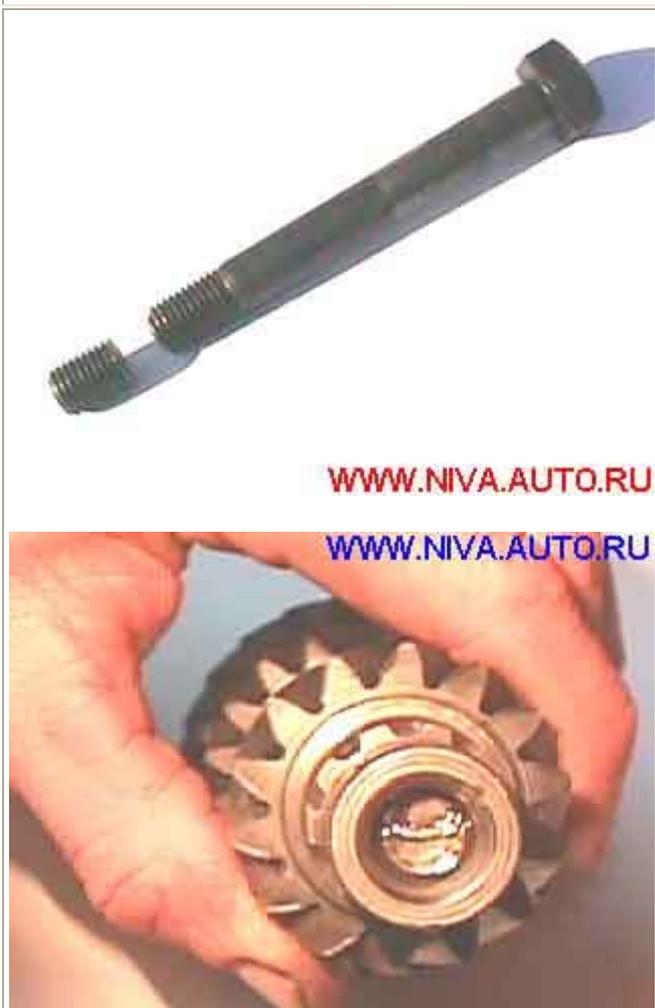
Broken gear cluster bolt

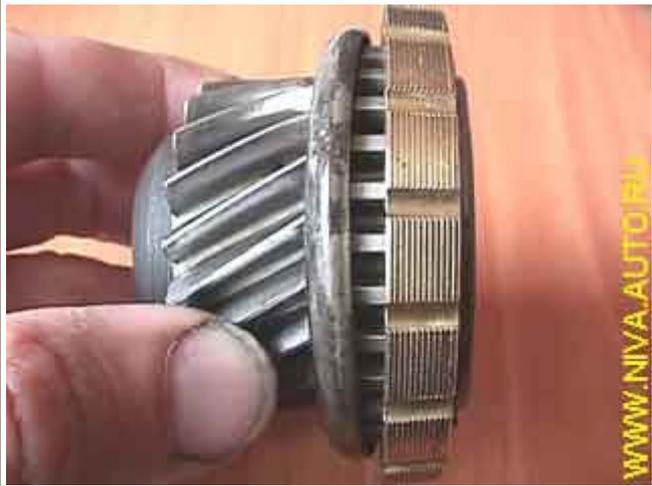
Denting of the synchronizer spring persistent ring. This ring is located between the gear's slanting and straight teeth, note in the picture how this ring is dented aside the straight teeth.

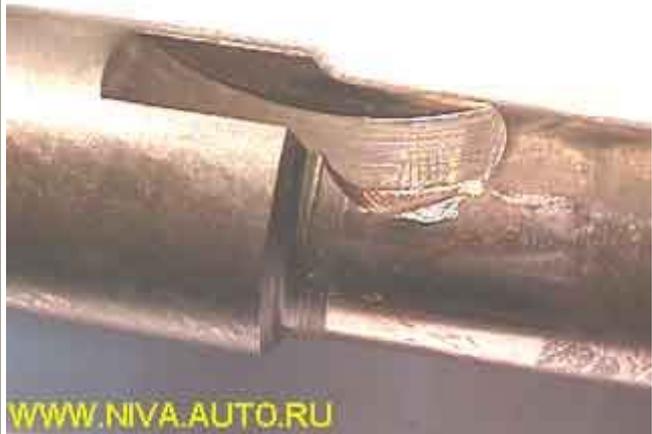
Deterioration and/or breakage of main shaft keyway

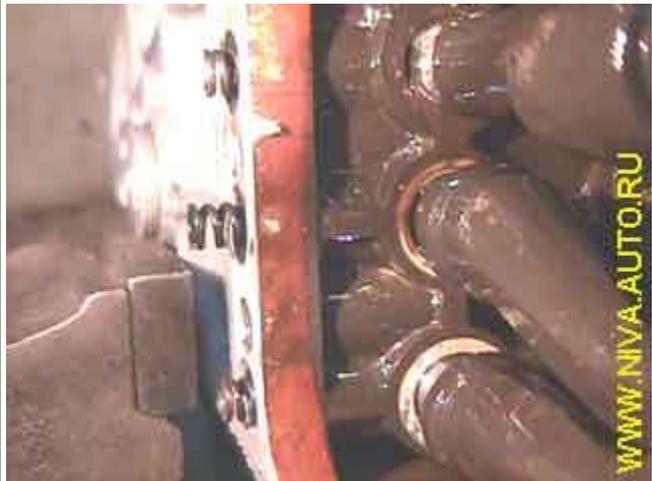
Incorrectly installed detent springs

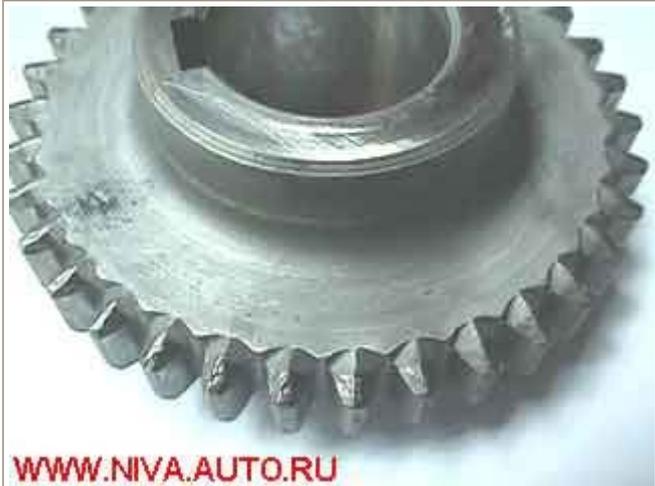
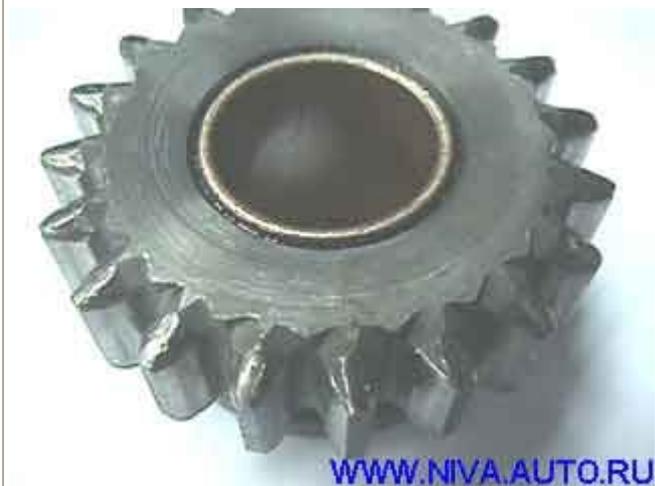
Deterioration of reverse drive and/or idler gear teeth faces

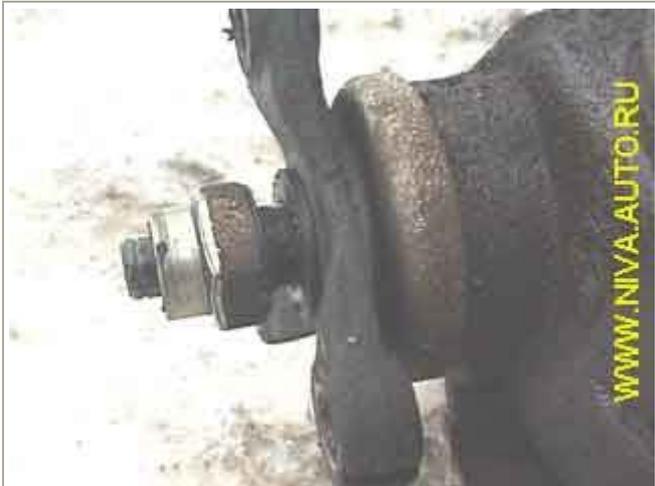
Loose output flange nut

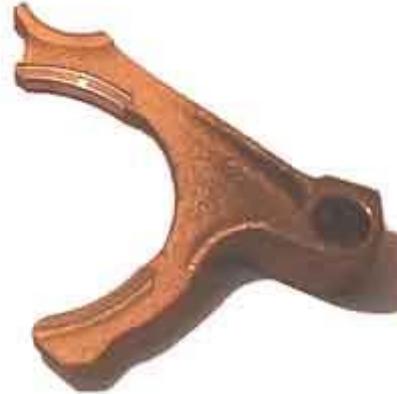
Deterioration of the 5th-reverse gear shift fork

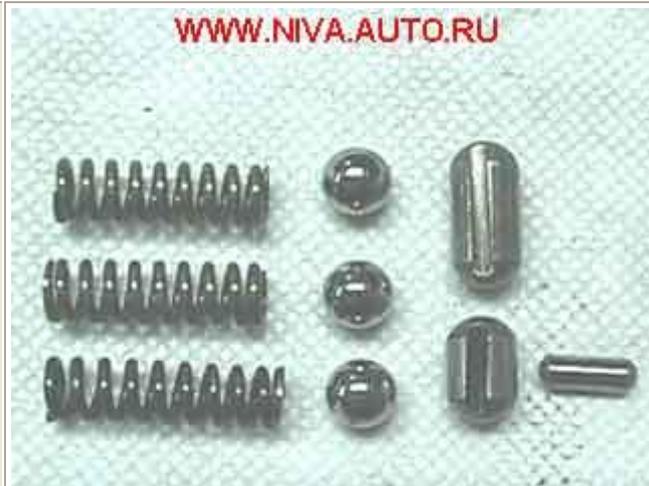
Deterioration of detent balls and/or interlock retainers, breakage or loss of resilience of detent springs

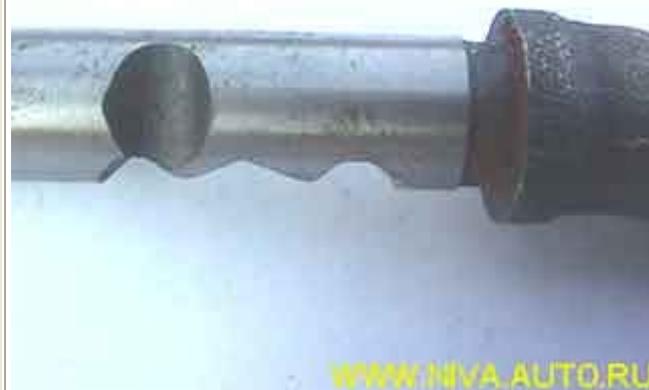
Deterioration of shift rails. The picture shows a serviceable rail, note the different places that must be checked for malfunctions

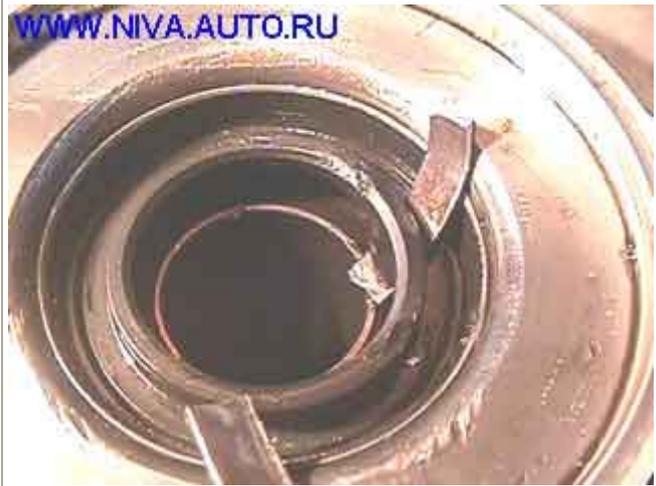
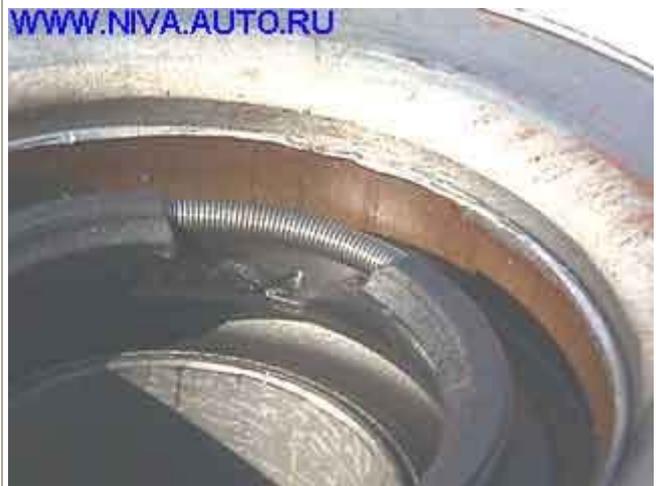
Deterioration of input and/or main shaft oil seals

Broken oil seals
